# Intake Exhaustion

A clever intake manifold solution ends the cycle of excessive oil consumption

## AFTERMARKET CASE STUDY

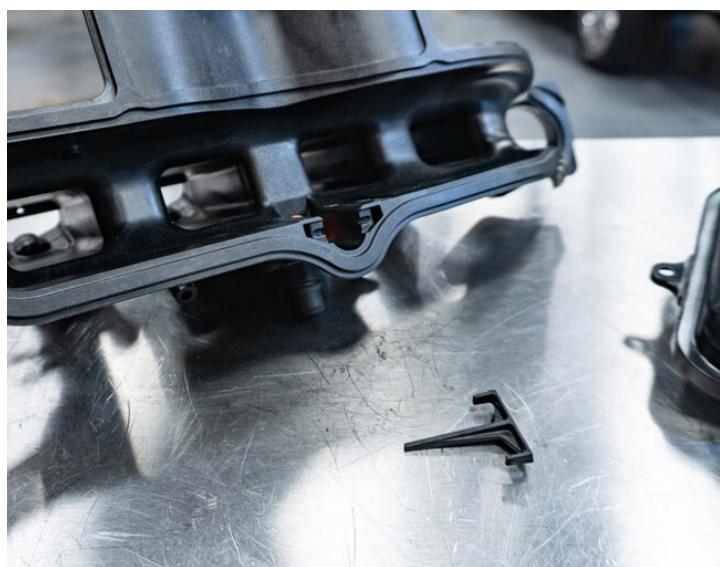
miles on it. This valve, little more than a simple rubber flap with a retainer tab on one side, drops out of its mount with nothing to secure it in place. Once this valve is gone (it's typically sucked through the intake system and combusted), vaporized oil is free to pass through the engine, resulting in the higher oil consumption.

When the valve in the factory intake manifold disappears it creates excessive vacuum, and that damages the fragile diaphragm integrated into the valve cover's PCV cap. The result is a rough running condition from air being drawn into the engine through this opening.

Replacing the original intake manifold with a new factory part may take care of the immediate problem, but it virtually ensures the owner will be making the same repair again in the future. Once Dorman's

ideation team looked at the source of the problem, they developed a smart solution to keep the valve located, even if its retainer should wear out. By incorporating a restraining pin into the intake manifold, the valve in this improved design is now captive, eliminating the chance it will ever become dislodged.

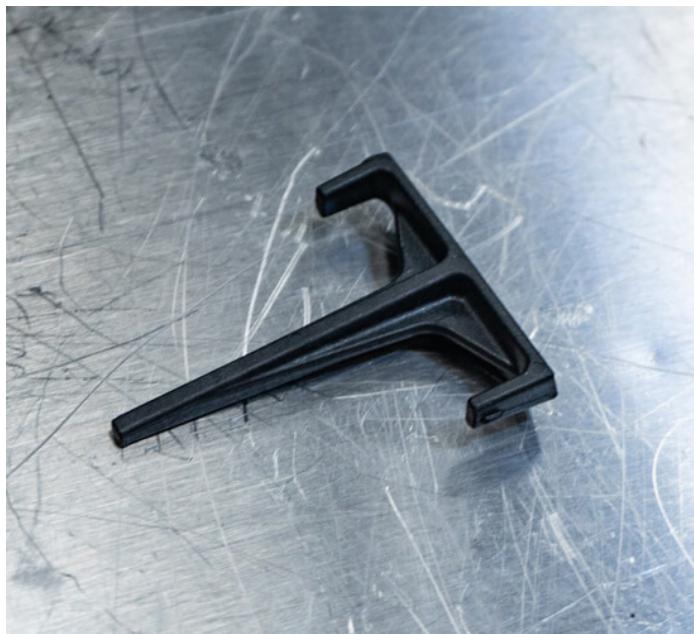
**Dorman's OE FIX** intake manifold takes care of the inherent problem in the OEM design, but the team's engineers discovered the troubles didn't end by just replacing the manifold. The original failure has a side effect, causing damage to other critical components.

The proper fix is to replace both the intake manifold and the valve cover at the same time. With Dorman's OE FIX intake manifold (615-380) and direct replacement valve cover (264-968), owners can end the cycle.
