# GUATEMALA

## Trocha 13 Community

# WATER

## Project Details

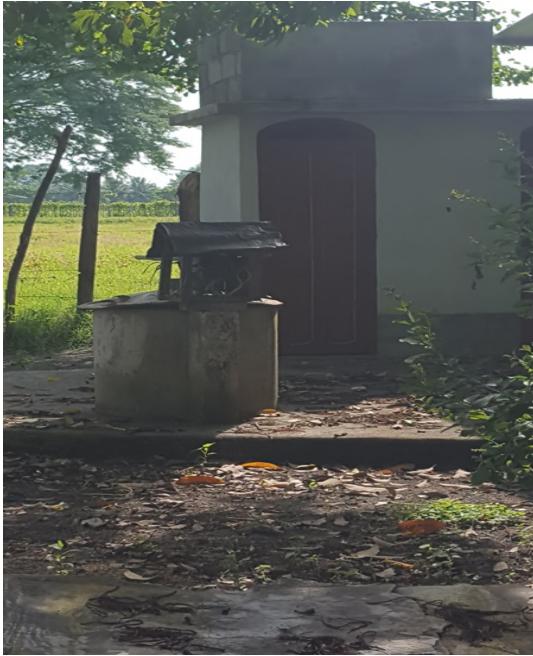
This is one of the wells the community members used before they were given a safe water well. This shallow well does not provide the potable water the community members need.

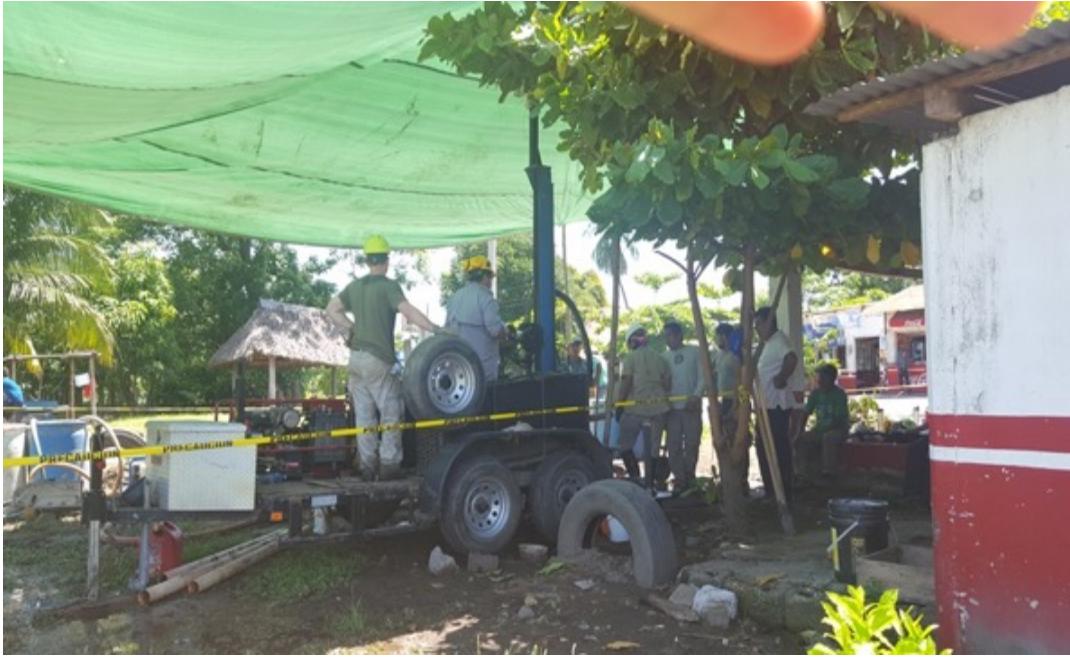
The Living Water Trips team and field team begin drilling on the first day of work.

When the field team and Living Water Trips team arrived in the community, they got to work right away setting up the drill rig. They reached an aquifer at 60 meters deep and then installed the PVC casing and flushed out the debris. The team then added the gravel pack, poured a concrete platform, and capped the well with an Afridev hand pump. Everyone involved in the project was overjoyed to see safe water pouring from the new well.

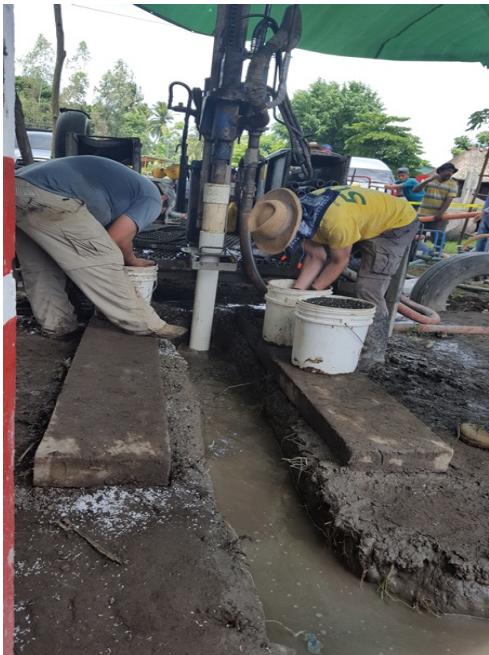
The team packs gravel around the casing.

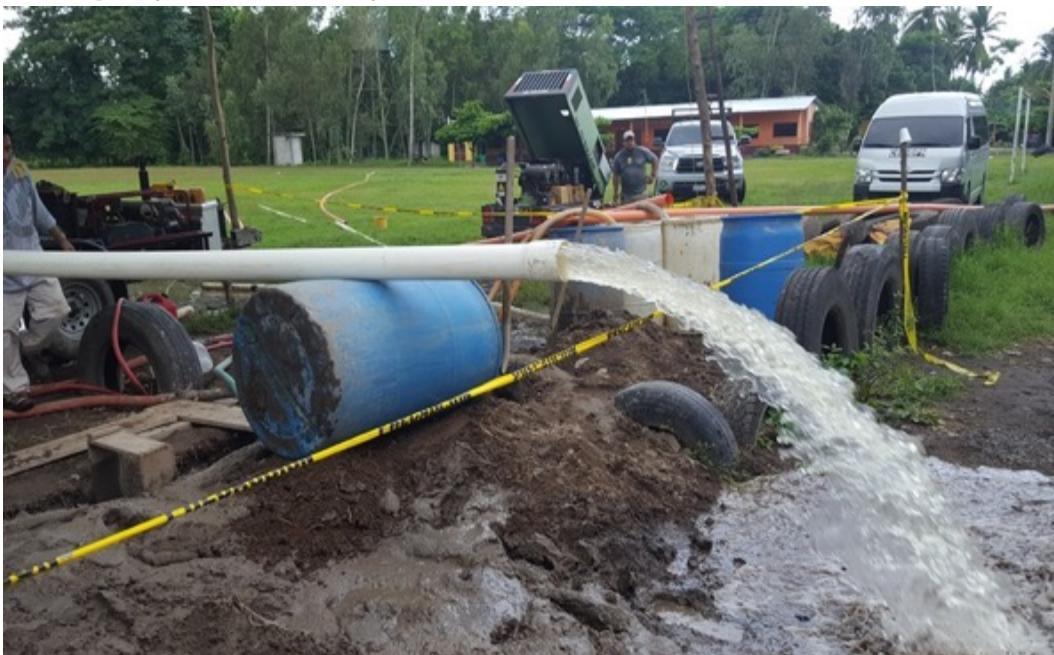
The team turns on the air compressor, and the first bit of water from the well flushes out. They continued flushing the well to ensure the borehole was free of debris.

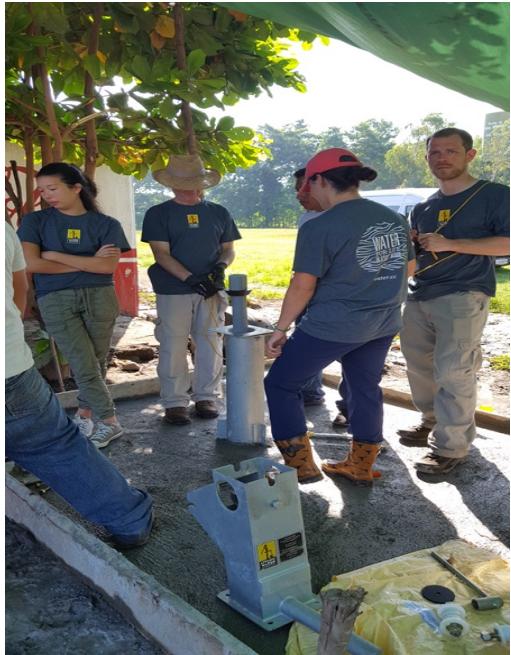
The team finishes added PVC piping and then installs the hand pump.

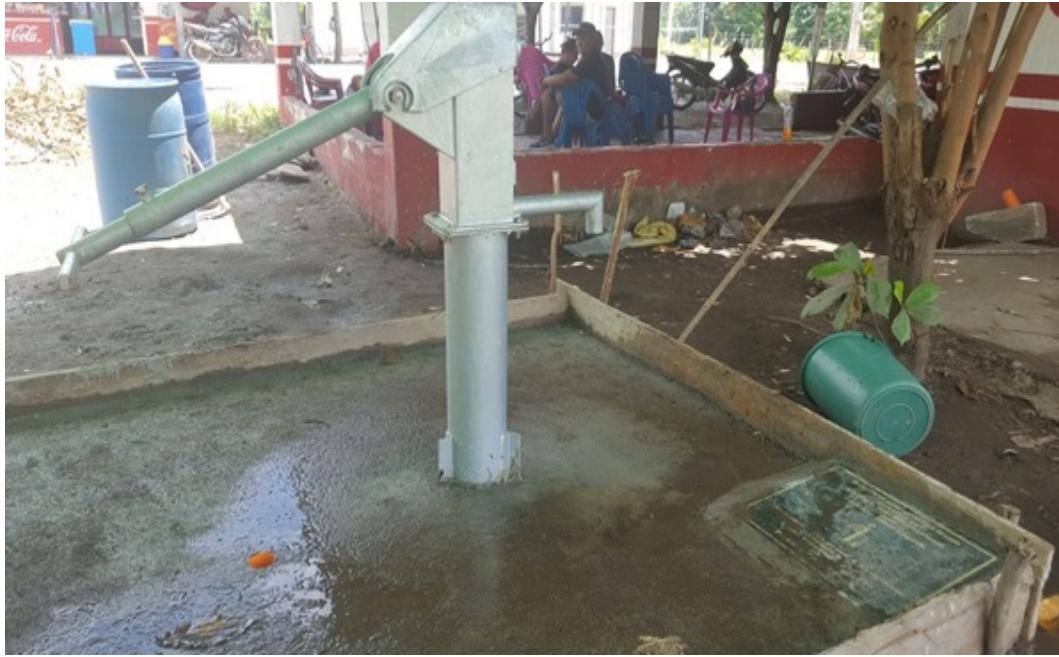
The completed well, platform, hand pump, and plaque are ready for use!

Platform is concrete with reinforcing steel	Yes
Dimension of Platform (H*W*L)	0.20*2.50*2.00 m
Drainage Channel or soak pit installed	Yes
