Seismic Risk of Building Types

Seismic Damage can be reduced or prevented.

March 11, 2019 | Greg Gavasse

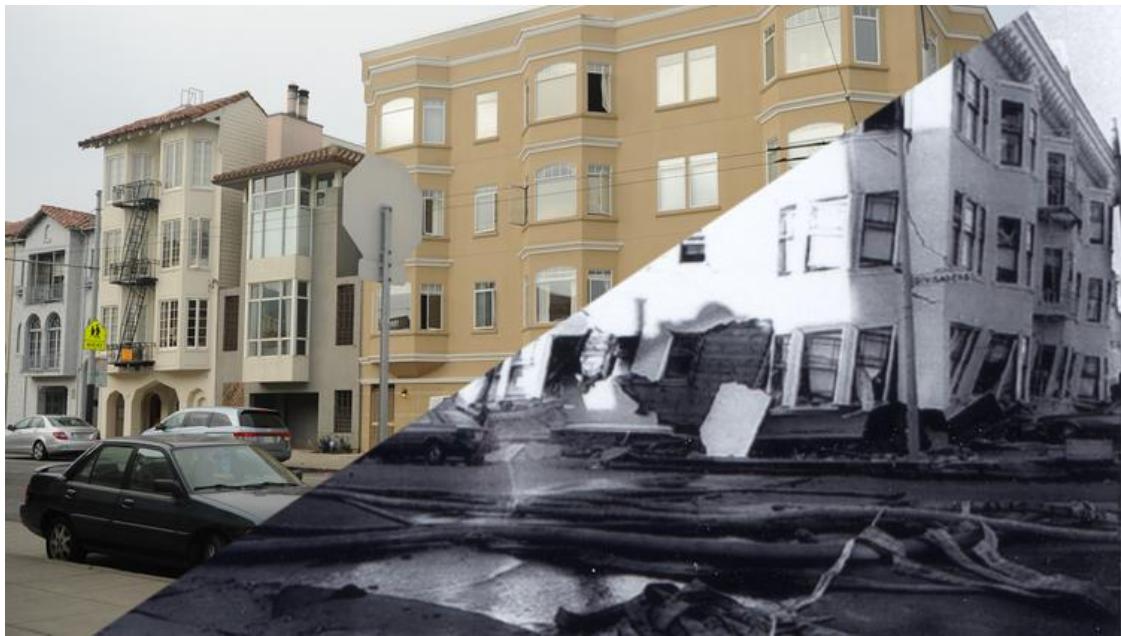
Before & After Photo – Loma Prieta Earthquake 1989, San Francisco.

Note equity owners, insurers and lenders are evaluating buildings with more and more intense scrutiny for the potential of seismic risk / damage. This is largely based on prior losses from significant historical earthquakes. For example, the 1989 Loma Prieta earthquake caused more than \$6 billion in damage and the 1994 Northridge earthquake caused over \$20 billion in damage. Financial institutions need specific and consistent measures of future damage loss for this decision process.
