Protecting Clean Water Together: Trouble With Dams

Written by: Carol Hillestad for the Brodhead Watershed Association

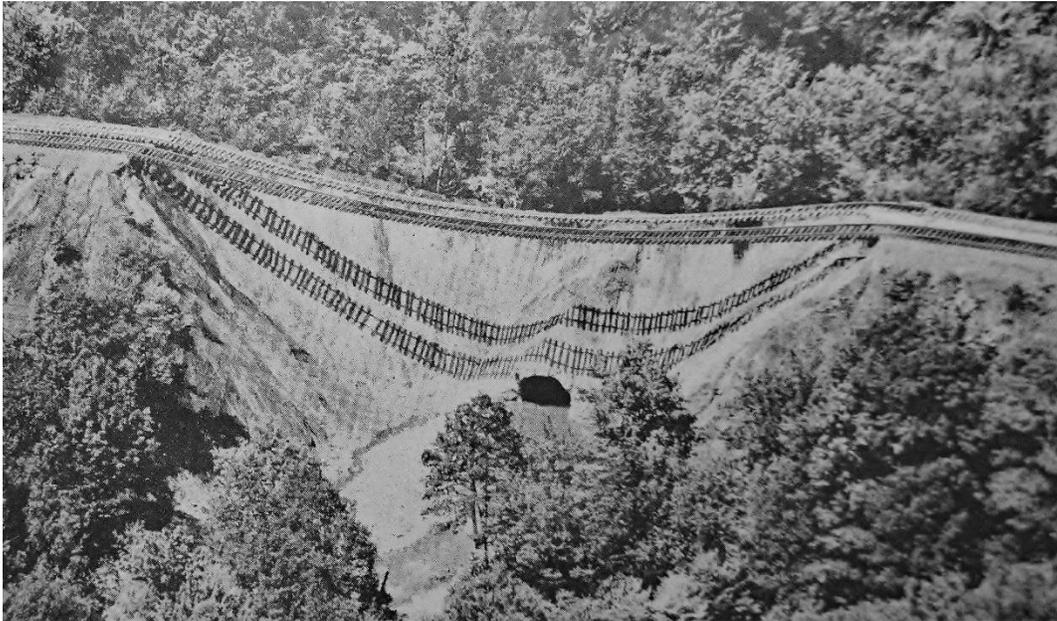
Photo of DL&W tracks hanging in the air after wash-out at Devil's Hole. Taken during fly-over by U.S. Army Signal Corps - August 1955. Notice remains of culvert at the base. (From Kim Williams collection)

Up near Mount Pocono, the Devils Hole Creek was trapped behind the 50-foot high railroad embankment. A culvert, which normally let the creek pass through,

had become blocked by debris. Floodwaters rose and rose, filling the creek valley like a lake — “stumps and tree limbs were bobbing at eye level,” one horrified eye-witness said — until the enormous earthen wall, overwhelmed, gave out. Now a monstrous torrent, the debris-laden water roared downstream carrying everything in its path, pounding down the Paradise to the Brodhead and into Stroudsburg.
