# FD STATION 4

Table 76: Facility Description: Falmouth Department of Public Works - FD Station 4

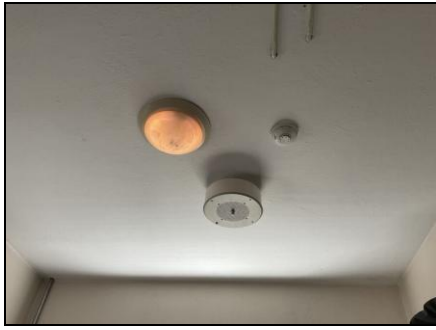
The fluorescent lighting was in fair condition due to observed inadequate lighting. The electrical branch wiring is beyond its recommended useful life. The service and distribution system was in good condition.

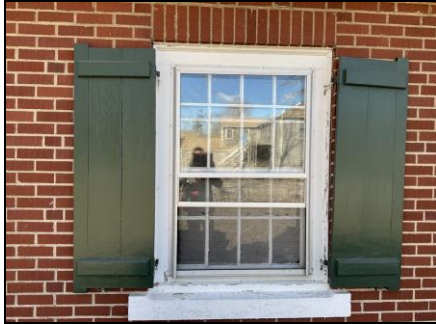
The wooden doors were in fair condition due to observed damaged panels. The single-pane windows were in poor condition due to observed damaged frames. The brick veneer and wood siding walls were in good condition; however, the wood siding walls were in fair condition due to observed faded finishes. The asphalt shingle roof covering was beyond its recommended useful life.

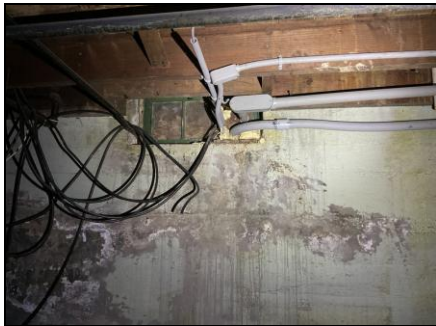
The hardwood, vinyl tile and carpet floor finishes were in fair condition due to observed excessive wear and stains, and the finished concrete floors were in poor condition due to observed stains. The painted wall finishes were in good condition; however, a portion of the painted walls were in poor condition due to observed deterioration. The painted ceiling finishes were in good condition.

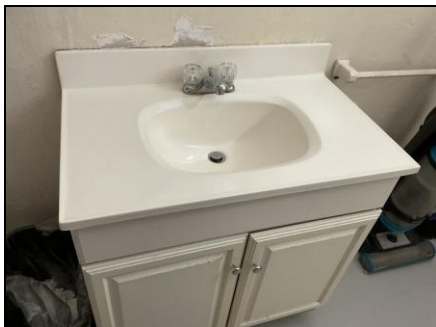
The porcelain and manual plumbing fixtures were in good condition. The domestic water distribution system is within its recommended useful life; however, a portion of the system is beyond its recommended useful life. The sanitary waste system is beyond its recommended useful life.
