Stained Glass Window Repair Update

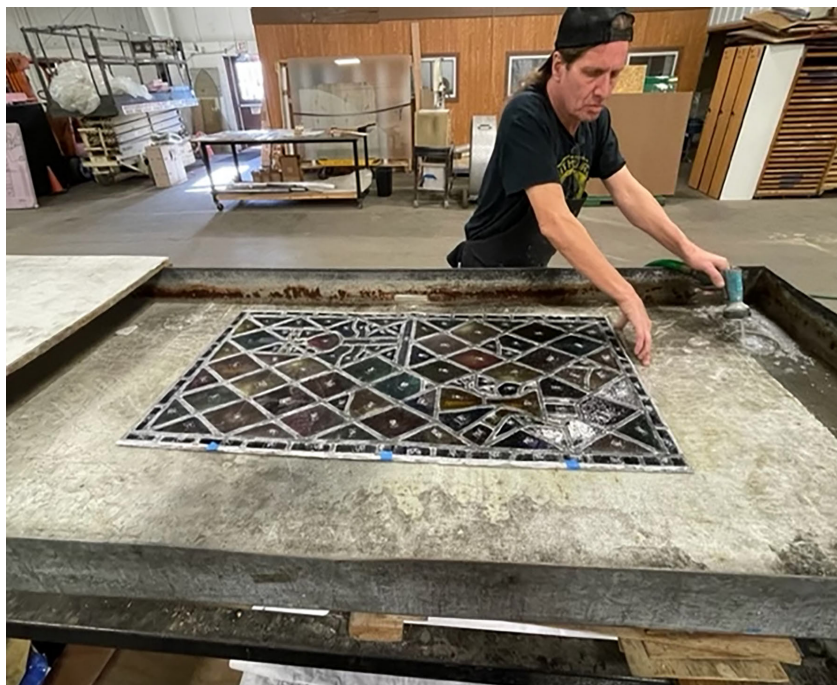
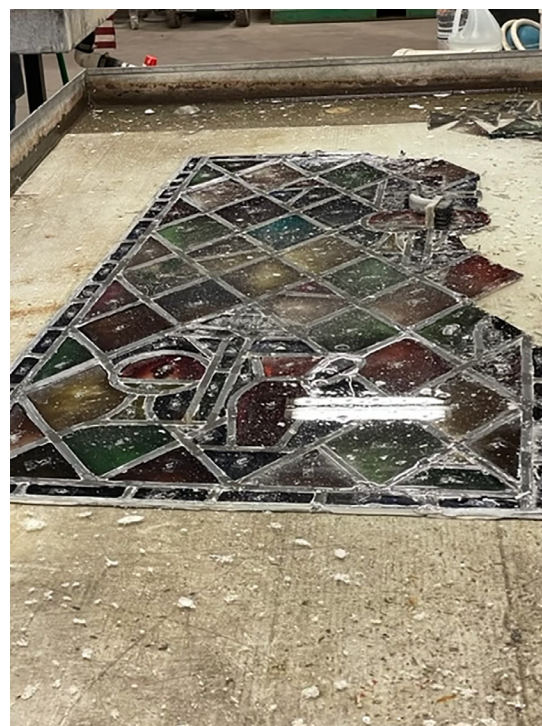
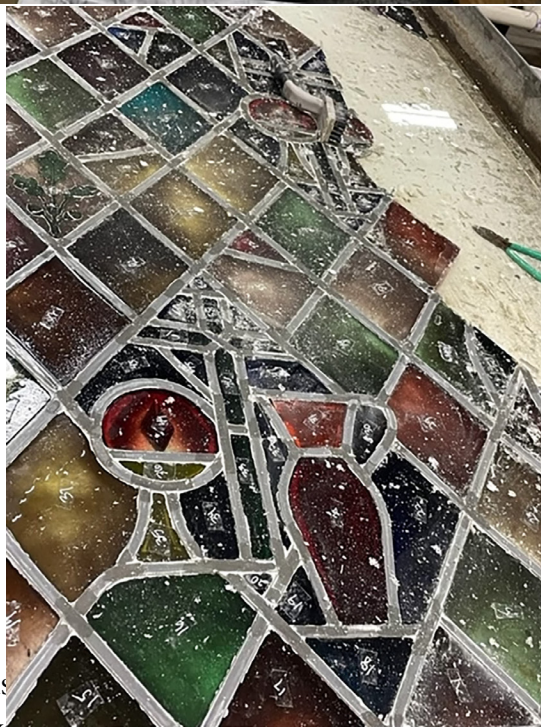
The east sacristy windows were badly bowed, the support bars no longer attached, and the “exterior perimeter sealants are mostly missing or in a state of failure, dried up” - these windows will be repaired and reset properly into their steel frames and resealed.

Here are pictures of the work in progress:

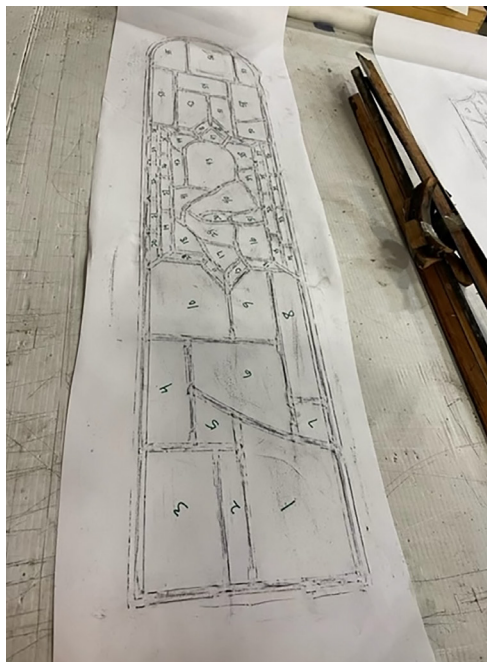
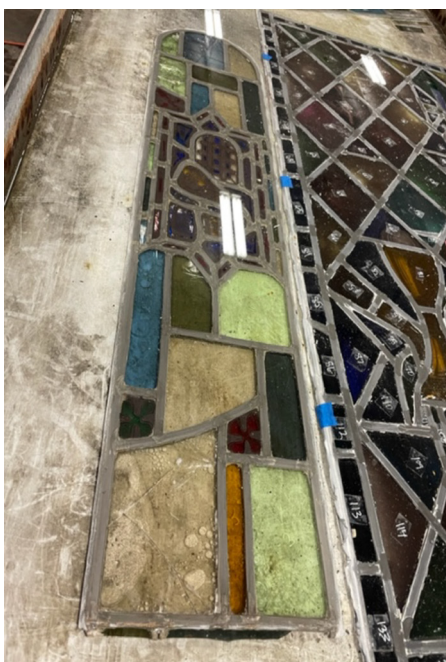
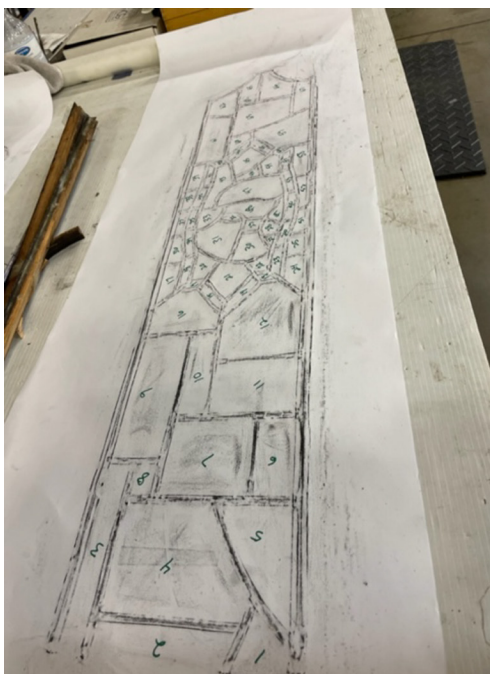
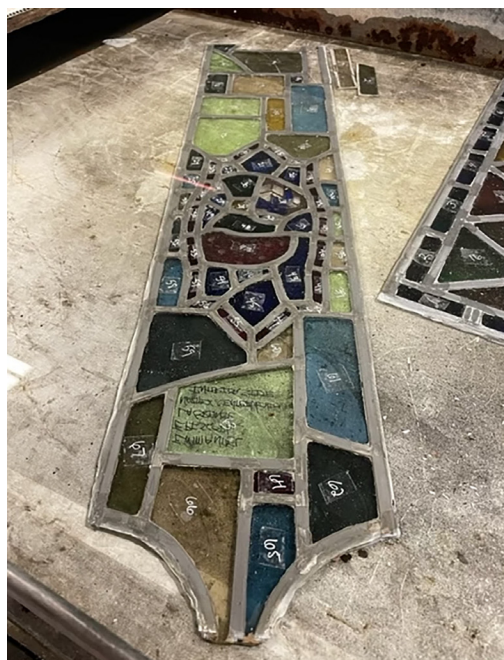
The two panels show line cracks which will be repaired (pictured below). The wooden molding holding these panels in place on the door was pulling away from

the frame and were no longer secure. When installed the molding will be firmly reattached. As you see from the images below – the window sections are numbered so that they can be re-assembled exactly.
