Behaviour of Spent Power Reactor Fuel during Storage

*Extracts from the Final Reports
of Coordinated Research Projects
on Behaviour of Spent Fuel Assemblies
in Storage (BEFAST I–III) and
Spent Fuel Performance Assessment
and Research (SPAR I–III) — 1981–2014*

International Atomic Energy Agency

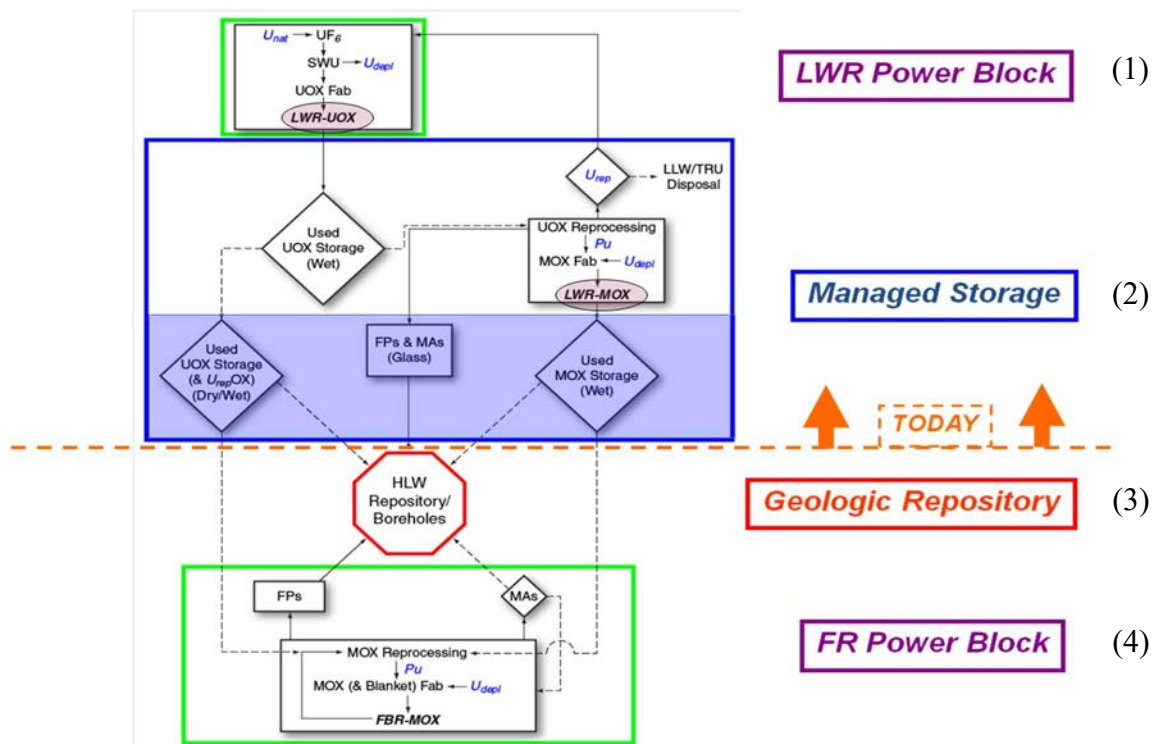
FIG. 1. Today's (LWR power block and managed storage), anticipated (geological repository), and potential (FR power block) nuclear fuel cycle elements (diagram courtesy of EPRI [17]).

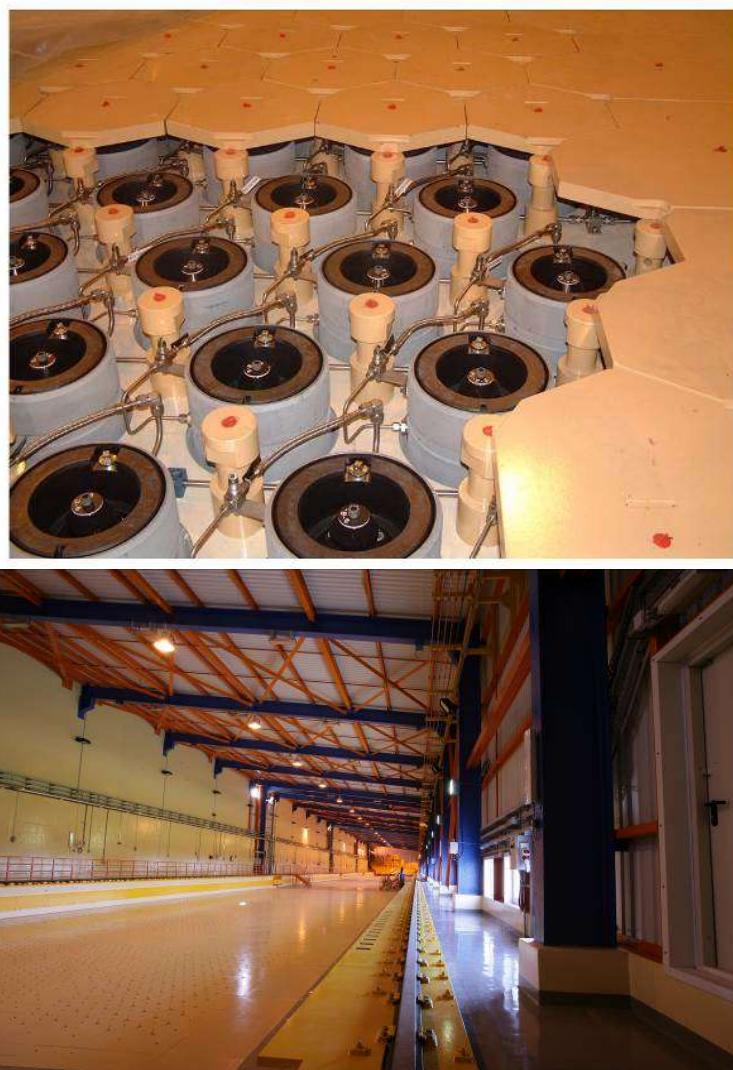
FIG. 7. Paks MVDS, operator PURAM, Hungary. Views of the top of the storage tubes and the charge hall (photographs courtesy of PURAM).

Figure 7 provides views of the modular vault dry store (MVDS) at Paks NPP (Hungary); the first system to be constructed for the storage of commercial water reactor fuel. Table 7. provides a summary of vault facilities in participating countries. Further information on vault stores is provided in Ref. [18].

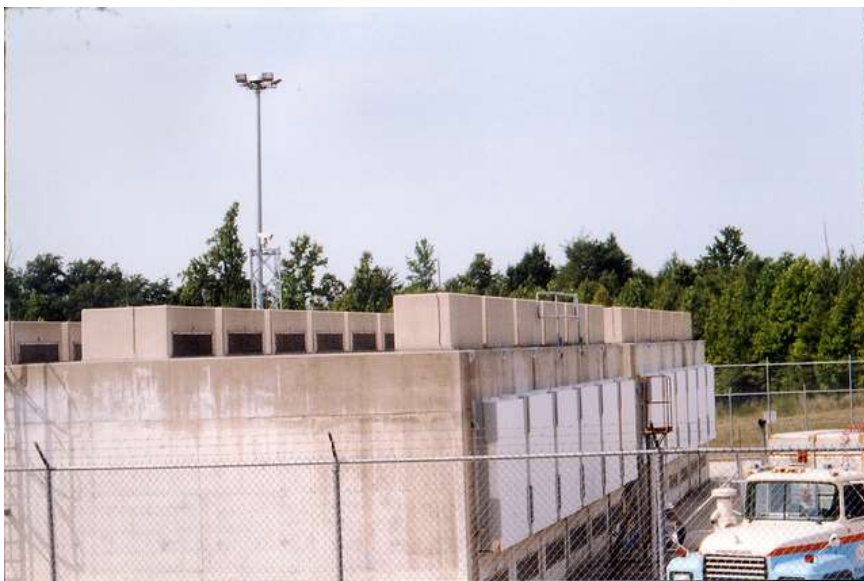
FIG. 8. NUHOMS[®] system at Calvert Cliffs (photograph courtesy of US NRC File Photo).

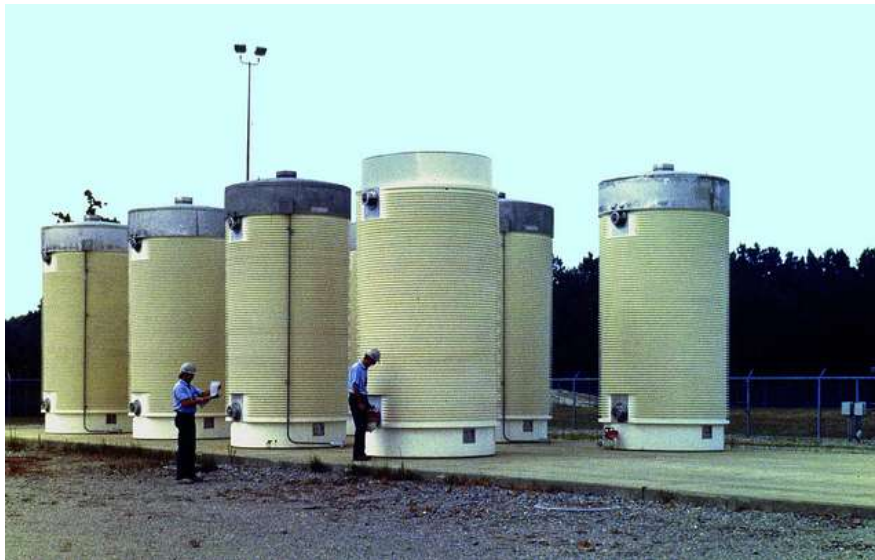
FIG. 9. TN-32 storage casks at Surrey NPP in the USA (photograph courtesy of US NRC File Photo).

Metal cask storage was reported by a number of countries such as Germany, Japan, Spain, Switzerland and the USA in various stages of the CRPs [1]. Some examples are shown in Figs 9 and 10.

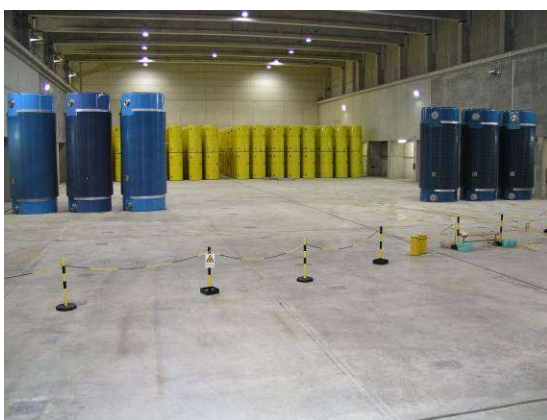
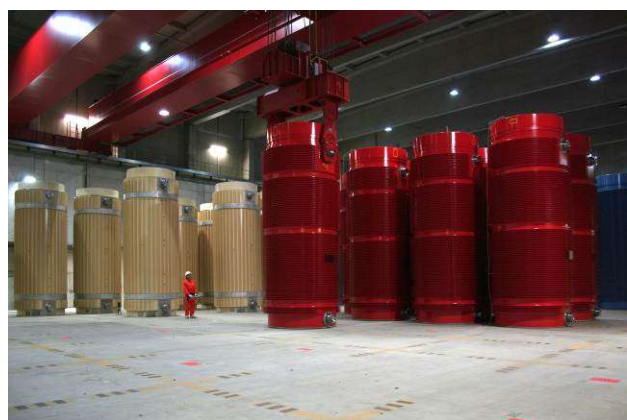
FIG. 10. CASTOR casks in Ahaus and Gorleben in Germany (photographs courtesy of GNS).

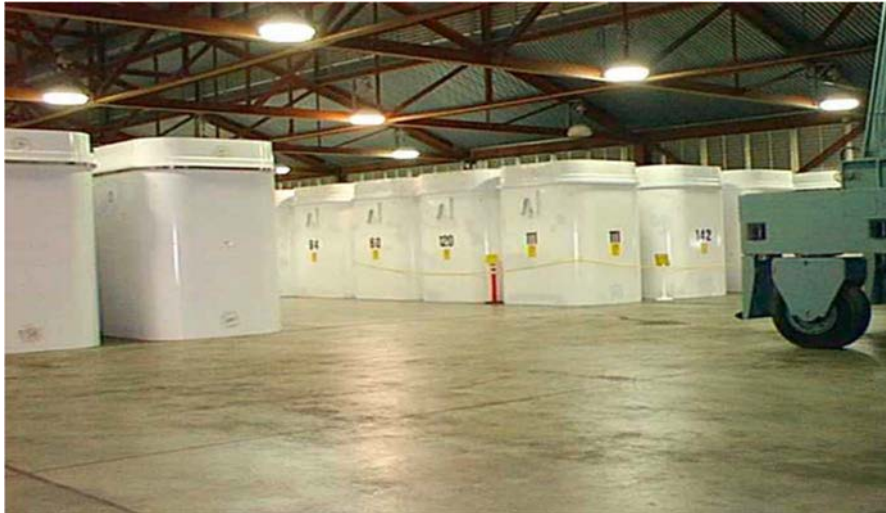
FIG. 11. CANDU DSCs (photograph courtesy of OPG).

The concept of using a concrete cask for the transport, storage and possible disposal of spent fuel was first investigated by Ontario Hydro (Canada). A demonstration programme was set-up in 1988, and the first commercial system using this technology, the dry storage cask (DSC) as shown in Fig. 11, was later deployed in 1996.

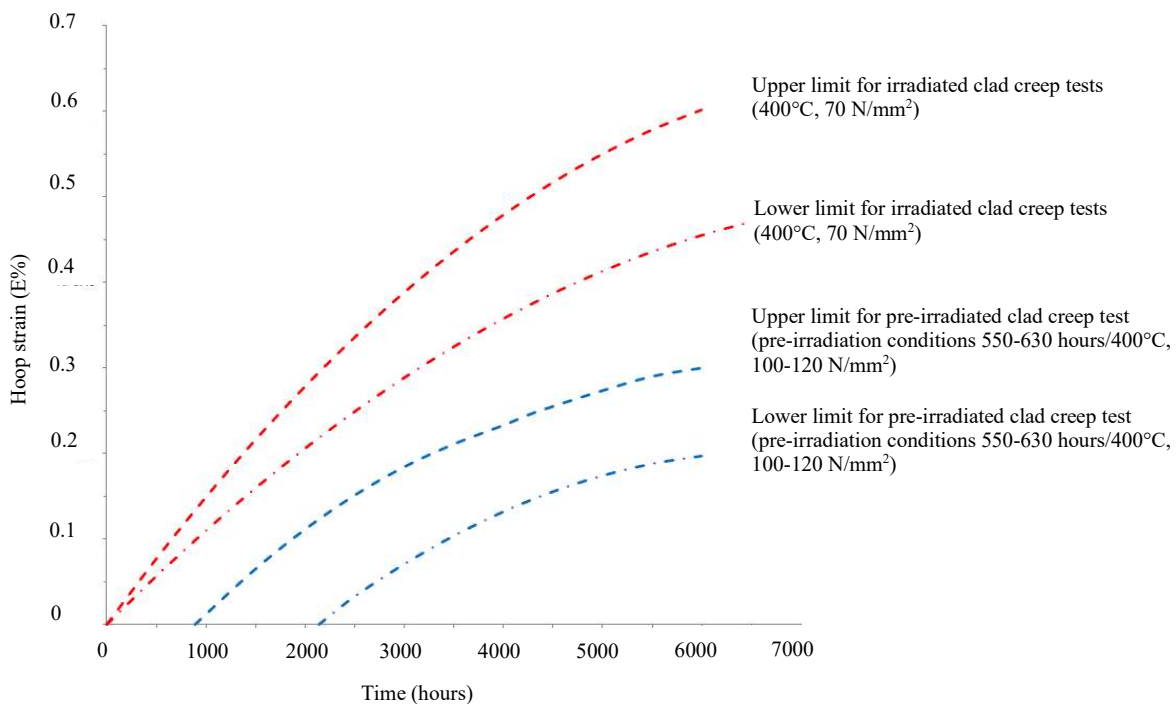
FIG. 15. Comparison of creep strain of irradiated and unirradiated Zry-4 cladding adapted from [4].

Conservative application of correlations obtained on unirradiated claddings to conservatively predict post irradiation thermal creep behaviour of irradiated claddings. The degree of conservatism can be obtained by comparing creep data of unirradiated and irradiated alloys (Fig. 15);

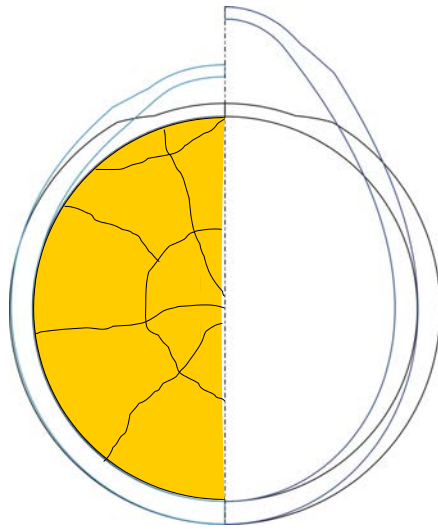
FIG. 18. Comparison of the creep response of a fuelled rod (left side) with the empty tube creep test simulation (right side), illustrating the constraining effect of fuel pellets on the local creep deformations (figure courtesy of EPRI [4]).

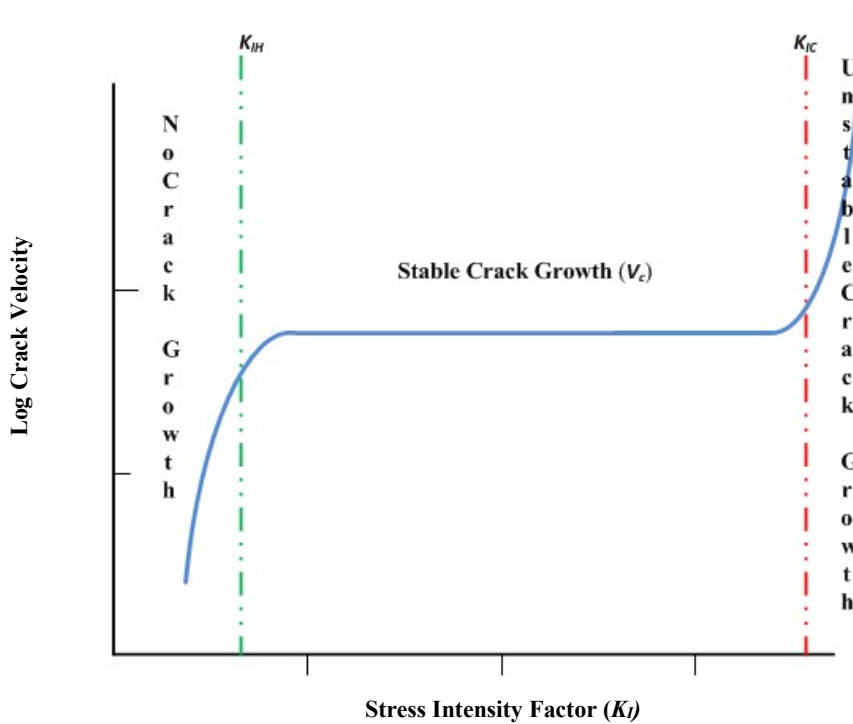
FIG. 19. Schematic representation of the dependence of the crack velocity as a function of the stress intensity factor, K_I . K_{IH} is the value of K_I at the transition between Stage I and Stage II. K_{IC} is the value of K_I at the end of Stage II, which is associated with unstable crack growth

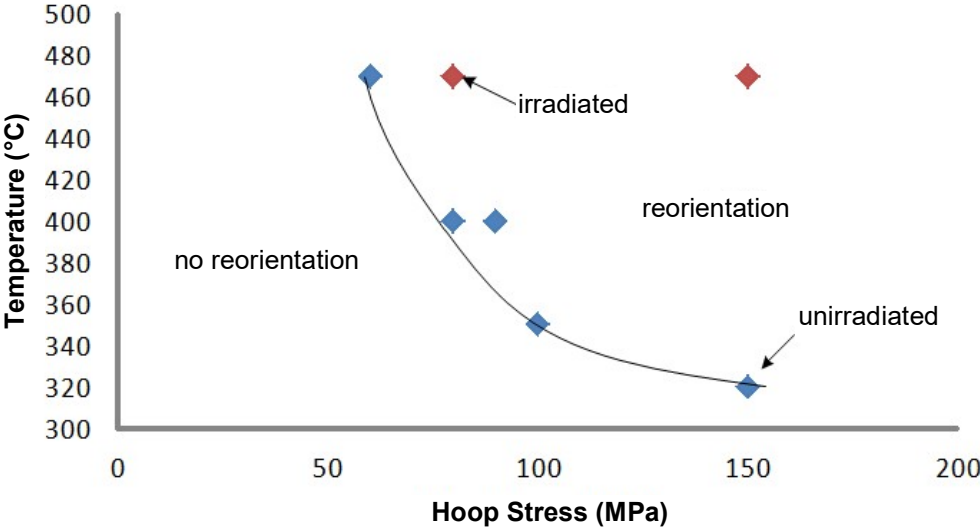
FIG. 20. Hydride reorientation domains vs. stress/temperature, adapted from Ref. [24].

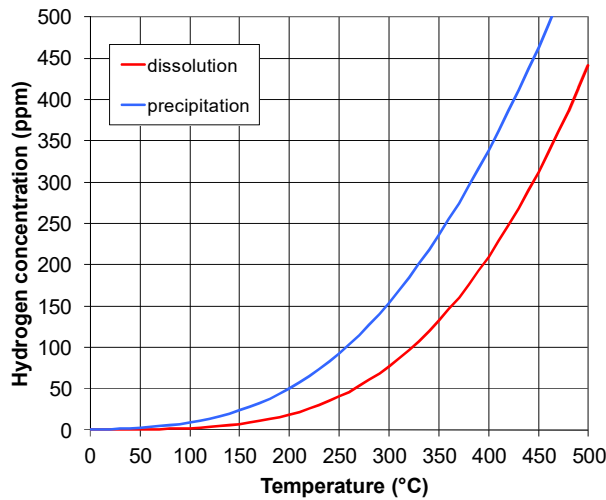
FIG. 21. Solubility curves for alpha annealed Zry-4 (adapted from Ref. [33]).

When the alloy contains 500 ppm of hydrogen, ~210 ppm of hydrogen is in solid solution upon heating to 400°C as stated in the previous example, with the balance of H (~290 ppm) being unaffected and remaining as hydrides. Upon cooling, K. Colas [34] found, using in situ XRD, for unirradiated cold worked stress relieved annealed Zry-4 cladding, that some hydride re-precipitation may occur with no or little hysteresis when there is residual hydride present when cooling begins. Under these conditions, the threshold hoop stress for hydride reorientation was between 150 and 200 MPa, which is substantially higher than the threshold stress observed for samples with no hydride present at 400°C.

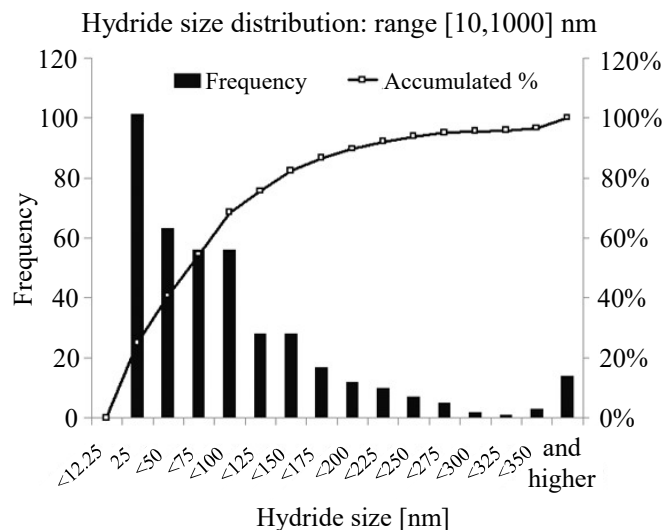
FIG. 22. TEM range histogram showing a hydride size distribution biased to small sizes. The maximum frequency is observed at 20-30 nm (courtesy of CNEA [7]).

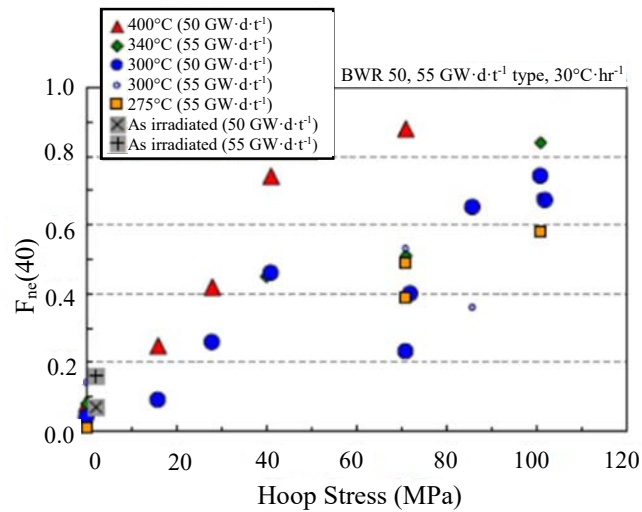
FIG. 24. Correlation between the normalized degree of reorientation, $F_{ne}(40)$ and the RHT conditions for irradiated BWR Zry-2 cladding with a zirconium liner (cooling rate: $30^{\circ}\text{C}\cdot\text{h}^{-1}$) (figure reproduced with permission from Ref. [31], copyright ASTM International, 100 Barr Harbor Drive, West Conshohocken, PA 19428).

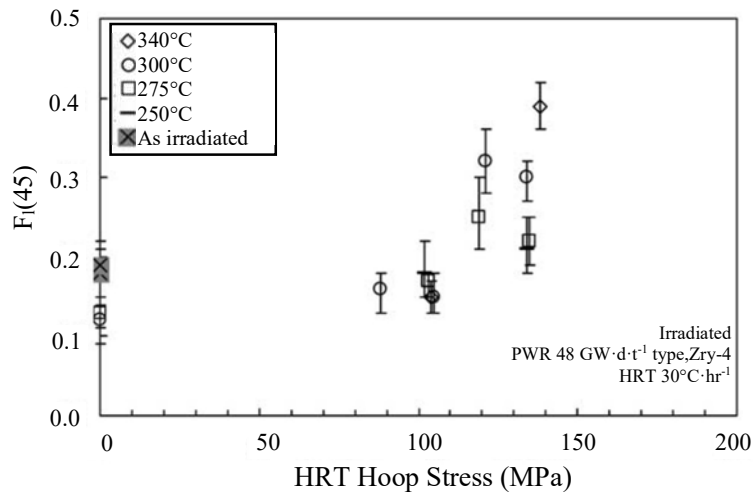
FIG. 25. Correlation between the degree of reorientation and the RHT conditions for irradiated PWR Zry-4 cladding (figure reproduced with permission from Ref. [31], copyright ASTM International, 100 Barr Harbor Drive, West Conshohocken, PA 19428).

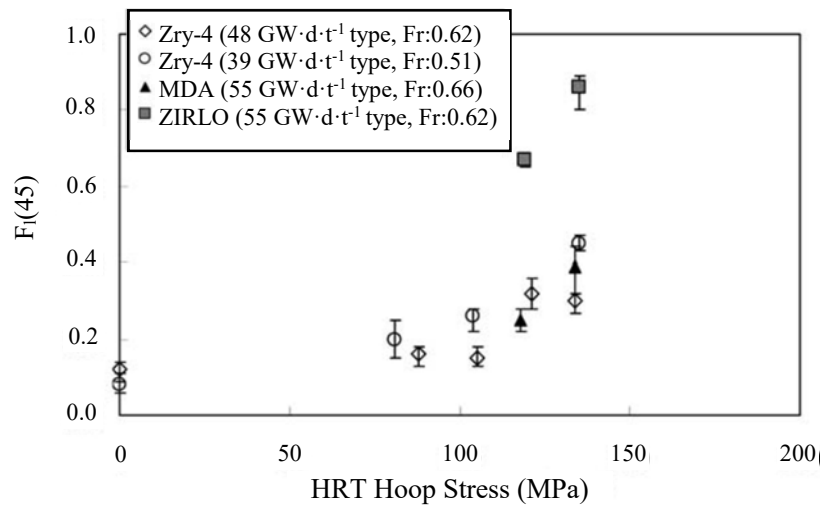
FIG. 26. Comparison of reorientation behaviour among irradiated PWR cladding materials (HRT 300°C, 30°C·h⁻¹) (figure reproduced with permission from Ref. [31], copyright ASTM International, 100 Barr Harbor Drive, West Conshohocken, PA 19428).

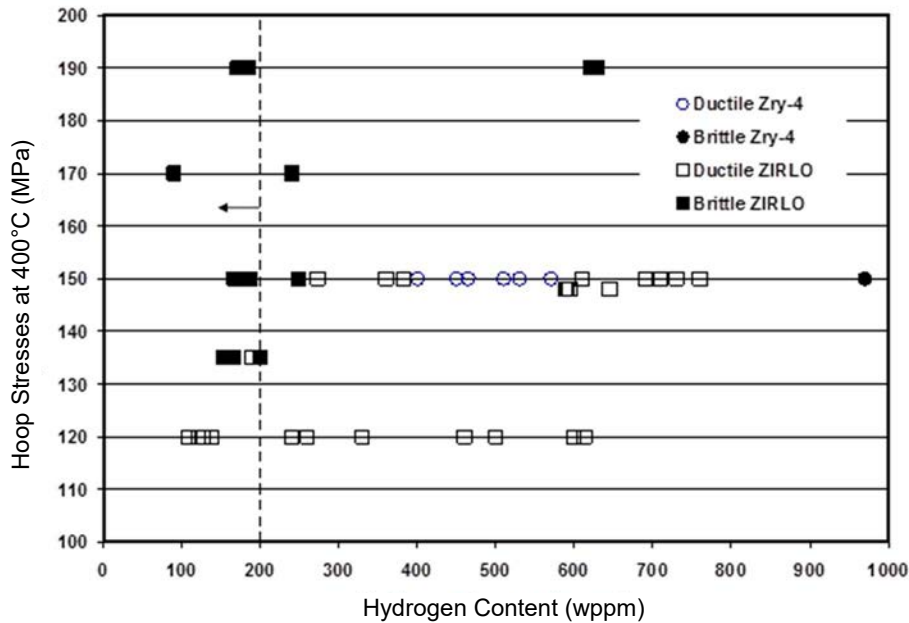
FIG. 27. RCT data at 150°C for pre-hydrided Zry-4 and ZIRLO™ following RHT (figure courtesy of U.S. NRC [7]).

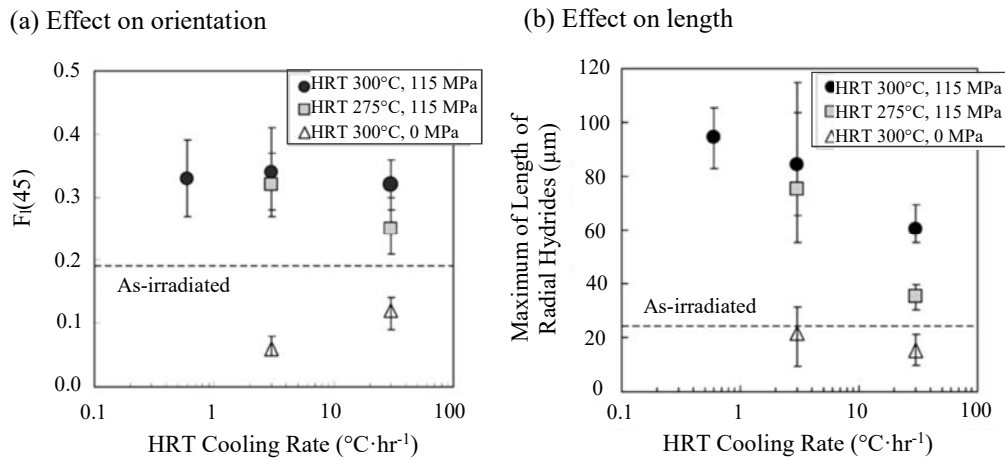
FIG. 29. Effect of RHT cooling on hydride morphology for irradiated PWR 48 $GW\cdot d\cdot t(HM)^{-1}$ Zry-4 cladding (the definition of vertical axis in (b) is “the maximum value among the length of hydride in radial direction $\pm 45^\circ$ ” (figure reproduced with permission from Ref. [31], copyright ASTM International, 100 Barr Harbor Drive, West Conshohocken, PA 19428).

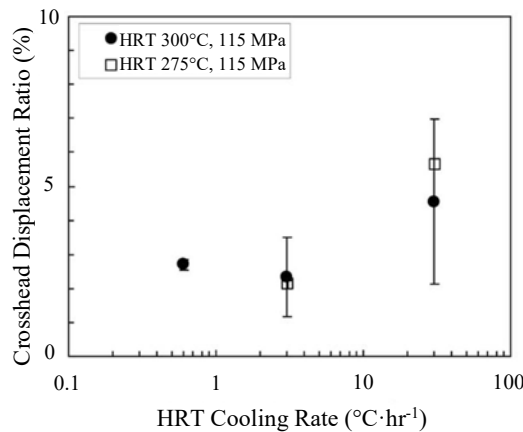
FIG. 30. Effect of RHT cooling rate on ring compression deformation for irradiated PWR Zry-4 cladding (figure reproduced with permission from Ref. [31], copyright ASTM International, 100 Barr Harbor Drive, West Conshohocken, PA 19428).

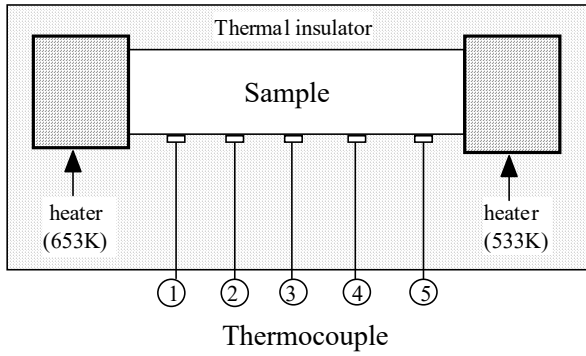
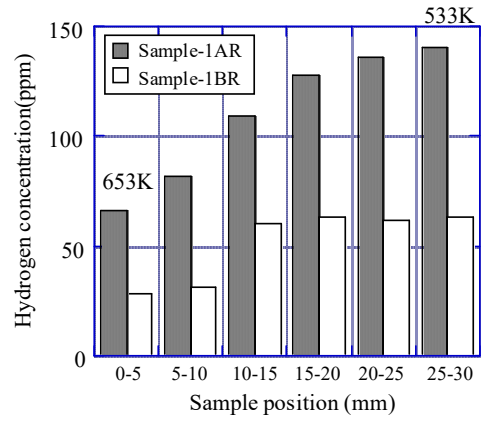
FIG. 31. Apparatus used for the hydrogen redistribution experiment (figure courtesy of CRIEPI [4]).

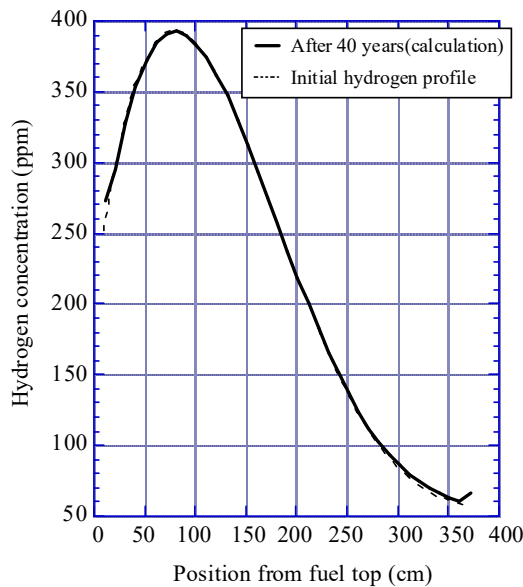
FIG. 33. Calculation of Axial hydrogen redistribution after 40 years of storage (figure courtesy of CRIEPI [4]).

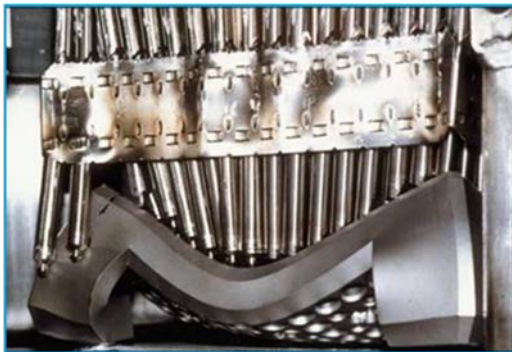
FIG. 34. Fresh PWR FA after 9 m drop test (picture courtesy of TN International and INS Ltd. [7]).

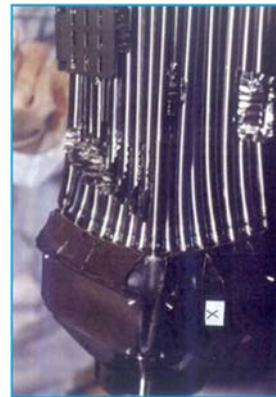
FIG. 35. Fresh BWR FA after 9 m drop test (picture courtesy of TN International and INS Ltd. [7]).

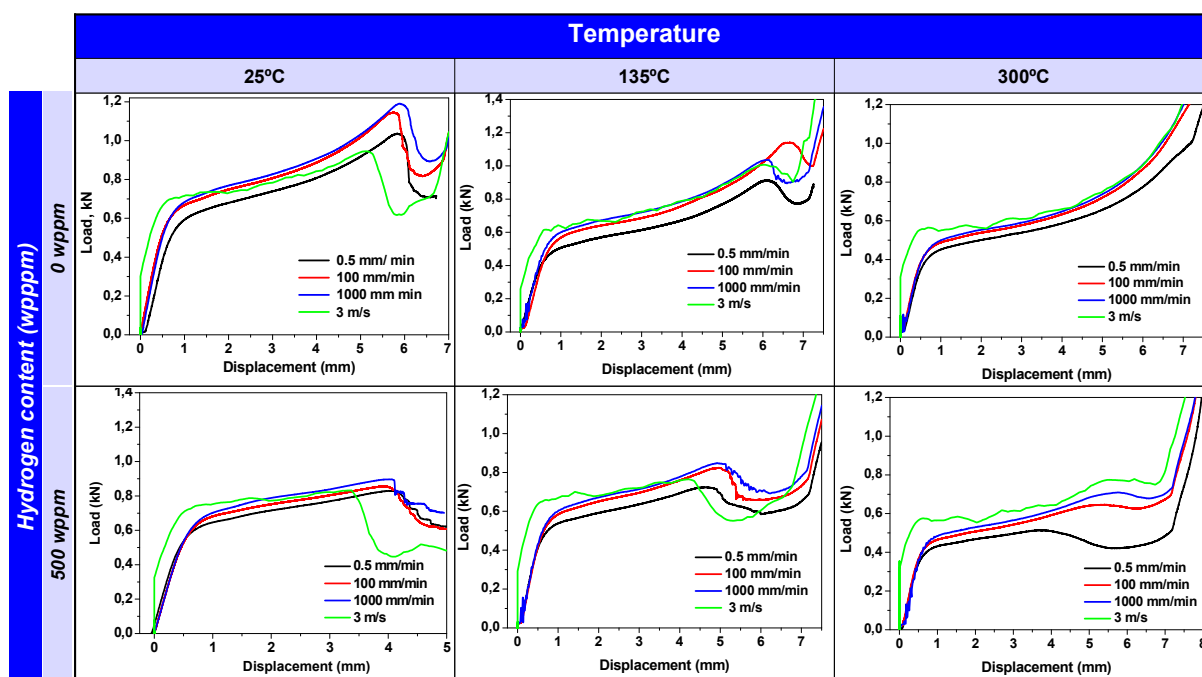
FIG. 44. Load versus displacement curves - static and dynamic RCT tests (figure courtesy of ENRESA [7]).

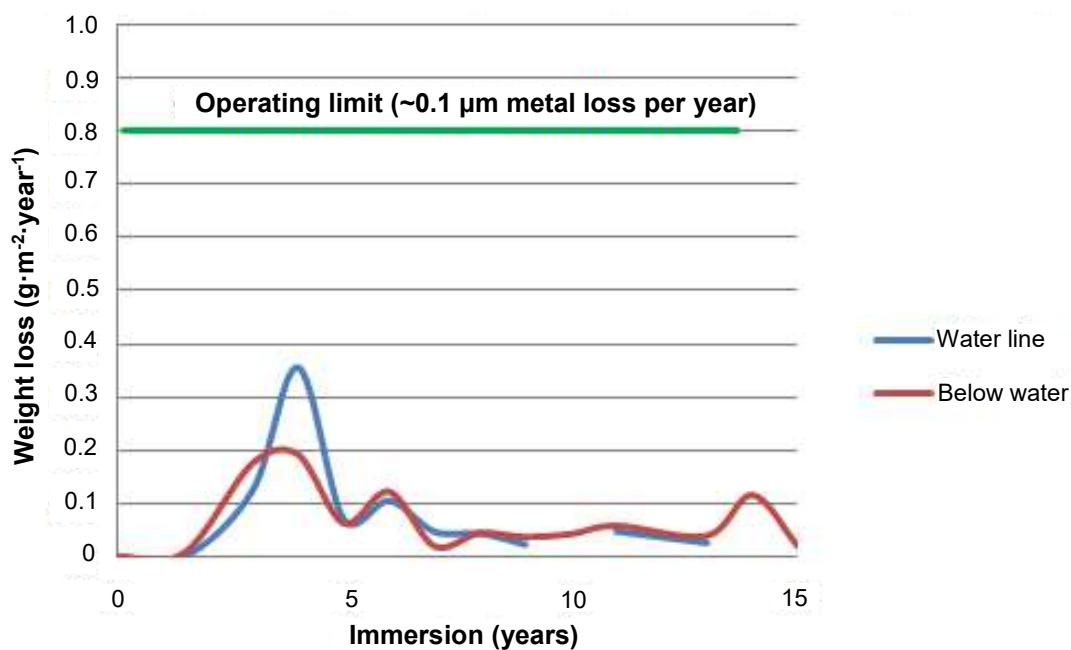
FIG. 48. Weight loss measurements for ANSI 321 stainless steel used in the pool liner.

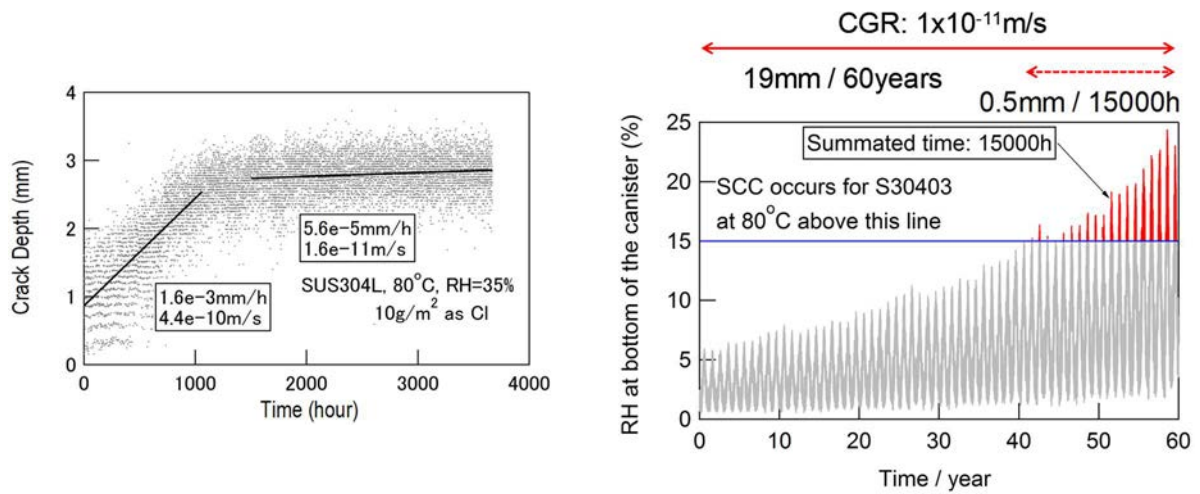
FIG. 50. Crack growth test results (figure courtesy of CRIEPI).

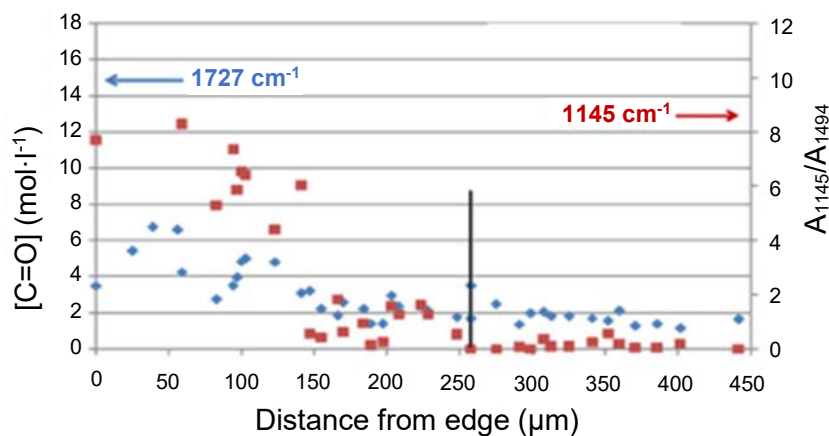
FIG. 53. Vyal B samples exposed to 160°C, 2 bar O_2 display a superficial layer (roughly 250 μm) while the core is not affected (figure courtesy of AREVA TN [7]).
