# Improvements Galore

*Daniel Price, Natural Resource Manager*

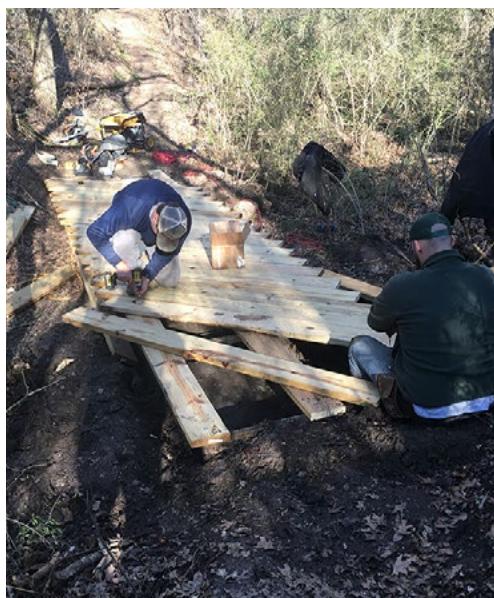
*Garrett Fannin (left) and CJ Aitken attach deck boards to the first Canyon Ridge Trail bridge. FWNC&R Photo.*

Thanks to the Friends of the Fort Worth Nature Center and a grant from REI, we recently replaced three bridges located on Canyon Ridge Trail with new and improved metal framework bridges. The previous wooden bridges were becoming unsafe for visitors. Although the new design required specialized skills such as welding, our staff has been trained and equipped with the tools needed to get the job done. The concept and design for the new and improved bridges were fairly simple. Driving metal pipe into the ground for a solid foundation, we constructed trusses with angle iron and rebar, which were placed on top of braces attached to the pipe. The final step was to attach the wood deck to the metal frame.

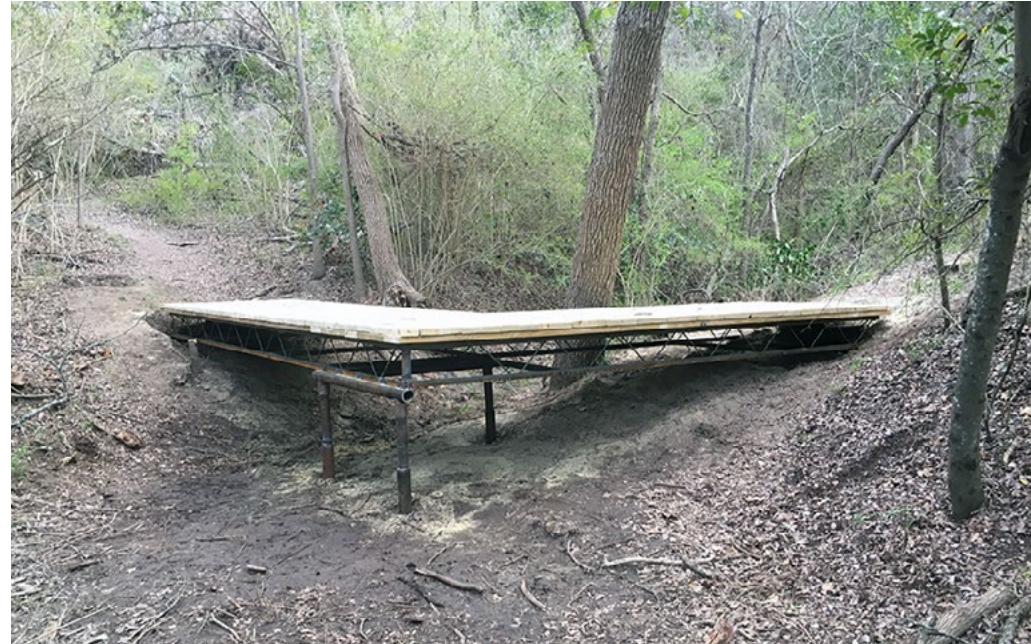
*The third—and final—bridge completed. FWNC&R Photo.*

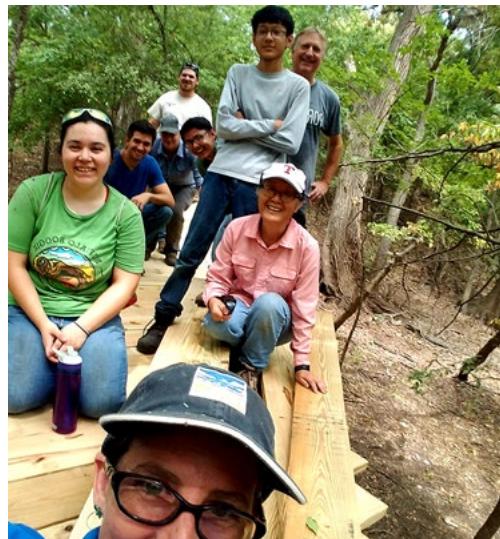
Working on Riverbottom's Slough Bridge with the  
Natural Guard and Nic Martinez. FWNC&R Staff  
Photo.

Over the past three years, construction has been completed on four Canyon Ridge Trail bridges (including the three mentioned above) and the 200-foot slough bridge on Riverbottom Trail. We have also installed new benches at several locations throughout the trail system and added an interpretive sign along the Oak Motte Trail. Other new features have included “trail closed” gates and trail counters at several trailheads. All utilized metal frames or were completely constructed of metal. We ask for your patience as we proceed with projects located throughout the entire 20-plus-mile trail system. We hope these projects will improve your experience at the Nature Center.

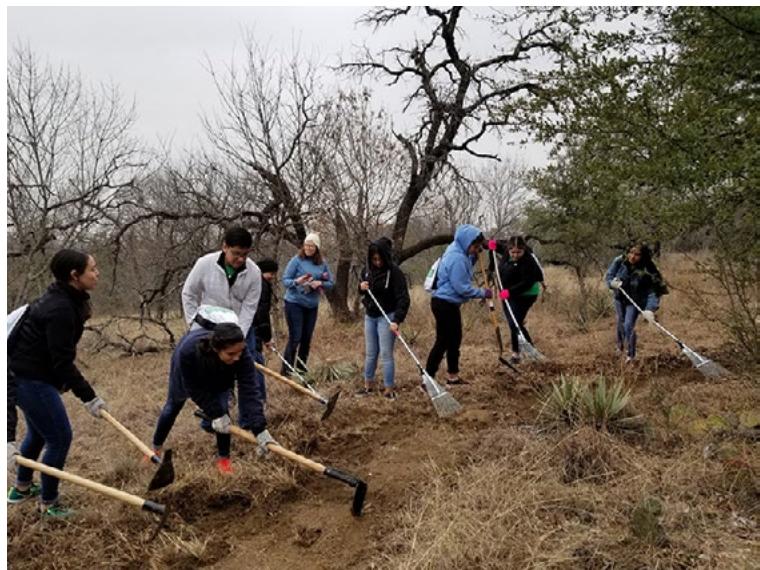
Constructing a new trail next to the Hardwicke Interpretive Center with the  
Marine Creek Land Scholars. FWNC&R Staff Photo.
