## 4B Components Ltd.

### Flour Mill

State of the Art Hazard Monitoring  
for State of the Art Flour Mill

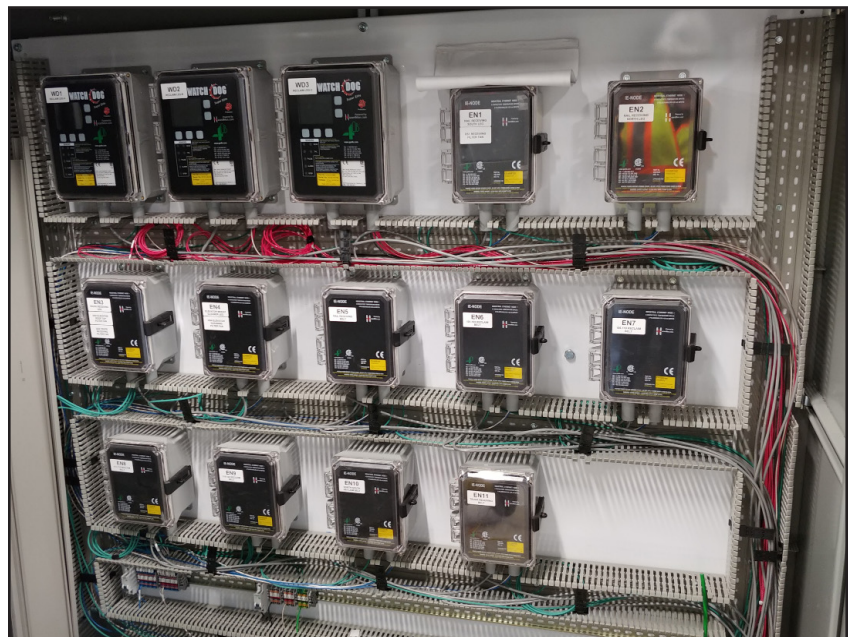
*Panel of IE-Nodes*

4B's newest hazard monitoring system, the Industrial Ethernet Node (IE-Node) was the perfect fit. It features EtherNet/IP

communications that work directly with the customer's Allen Bradley PLC without any gateways while being approved for Class II, Division 1 Group E, F & G hazardous dust environments. It provides inputs for continuous bearing temperature sensors, belt alignment sensors, and speed sensors. The customer selected the IE-Nodes because they are technologically superior to other options on the market and improve the flexibility of installation all at an attractive price. The IE-Nodes each have 10 inputs and can be expanded to 16 to provide even more flexibility in applications where the site needed additional sensors. All of the sensors can be fully tested with 4B's Speedmaster and ADB Tester and the system has the unique ability to have multiple speed inputs for the PLC to monitor the speed ratio on equipment operating with VFDs. The customer selected NTC Adjustable Depth Bearing (ADB) temperature sensors, 2" x 4" rectangular brass rub blocks with stainless steel hinged inspection doors for belt misalignment, and whirligigs with 4-20 mA Milli-Speed sensors for monitoring belt slippage. 4B provided training for both the end user and installer to highlight the best practices for wiring and maintaining the system.
