High Altar Mishap ...

This Week at Ascension – January 23, 2019

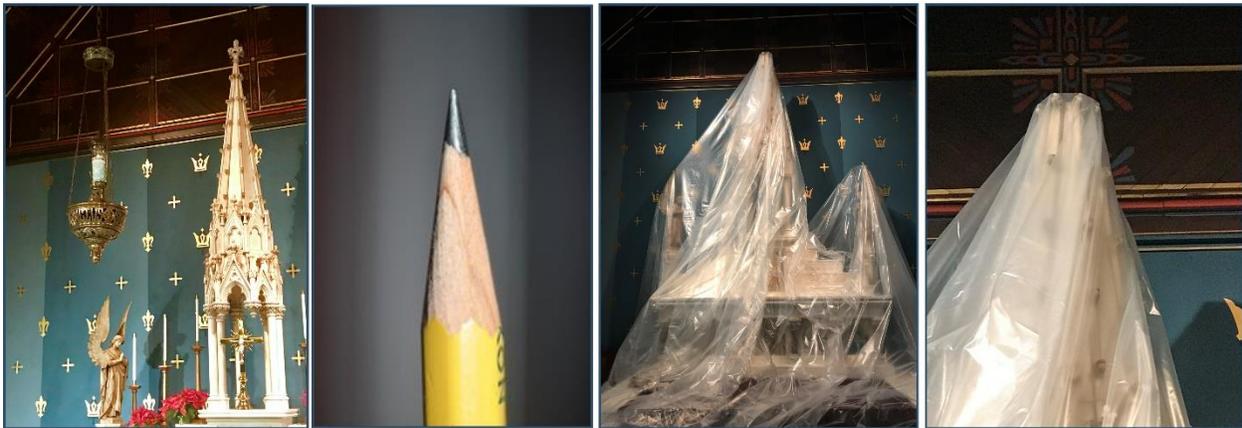
I'm sorry to have to report a mishap that will no doubt trouble all of you as it has me. In the process of covering the high altar with a large sheet of plastic on Monday evening in anticipation of the tuck pointing project, the tip of the altar spire, about 2 feet in total, tumbled to the ground and shattered.

The four pictures below may help you comprehend what happened. The picture on the left shows the altar whole (i.e. for the 120 years before last night). The pencil tip photo is included because the toppled tip of the altar can be envisioned, relative to the whole, as the lead portion of the sharpened tip of a pencil. The third and fourth photos show the altar crown as well as can be viewed with the plastic on it.

- ★ It was a clean break. It appears as if the altar was put together like a wedding cake AND it appears there was no apparatus to hold the topmost pieces together.

- ★ Although the altar-top fell on the altar surface proper, there initially appears to be no damage to it.
- ★ It may be possible to restore the damage! Marble craftsman John Rigali, from Daprato Rigali Studios, Chicago, has already examined the damage and is preparing proposals that include restoration, a replacement piece and cleaning of the entire spire.

- ★ If necessary, I'm quite sure that we will be able in the coming month to manufacture something that will adequately approximate what we've lost - not marble, of course, some kind of tromp d'oeil – as we await a permanent restoration. The 'clean break' I mention above will make this more plausible -- it would be much harder to deal with a diagonal or ragged break.
