# NONPOINT SOURCE SUCCESS STORY

## Mississippi

### Implementing Conservation Practices Reduced Polluted Runoff and Restored the Biological Integrity of Fannegusha Creek

EPA 841-F-19-001VV  
December 2019

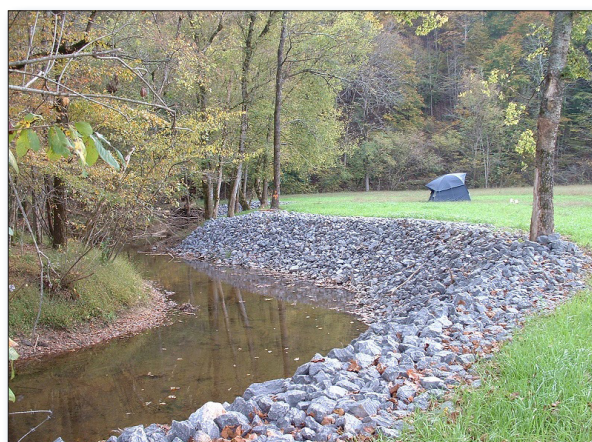
Figure 2. Grade stabilization structures were used to prevent erosion of streambanks.

| BMP type installed | Amount installed |
|---|---|
| Grade stabilization structure | 24 |

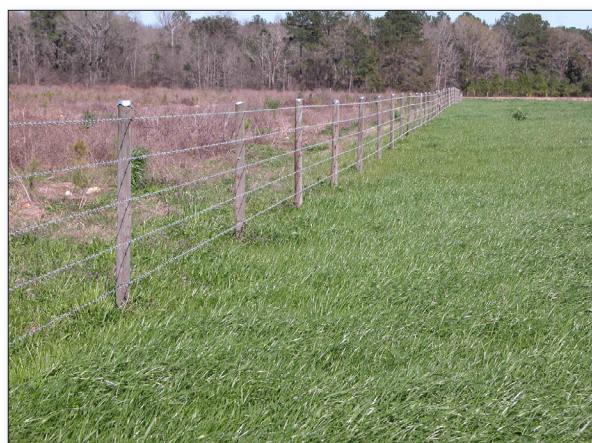
Figure 3. Fencing was used to provide a barrier to control livestock and manage sensitive riparian areas.

| BMP type installed | Amount installed |
|---|---|
| Fence | 82,439 ft |
