Re: Westhampton Landings Co-op  
3001-3050 Mitchell Road  
Westhampton Beach, NY 11978

RE: Roof Assessment

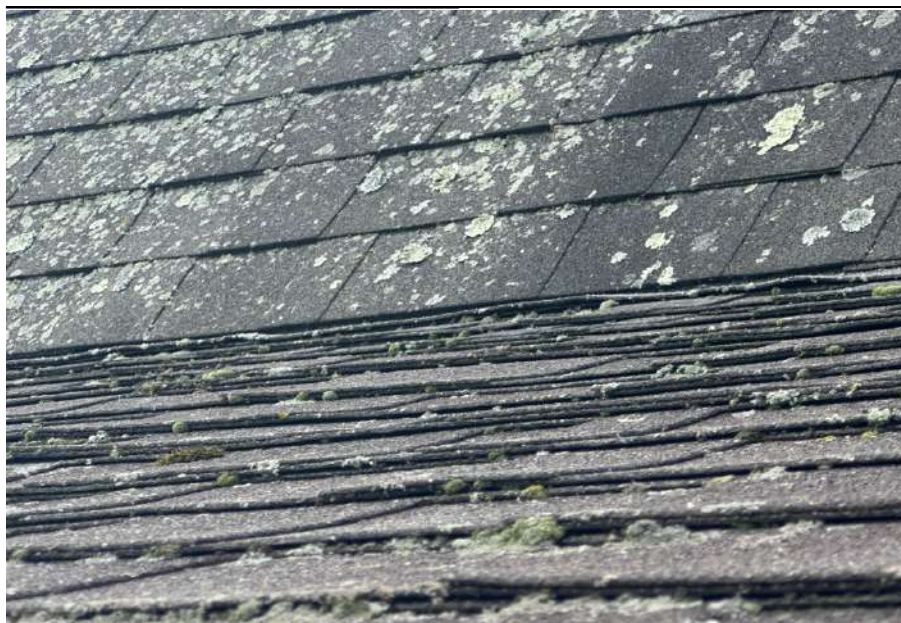
All of the buildings have asphalt shingle roof areas. The asphalt shingle roofing exhibited algae growth in some areas, particularly where shaded by trees and along north-facing roof areas. The algae impedes drainage. The trees are being well maintained with branches removed that overhang the roofs. Regardless, leaves filled up some of the gutters, particularly where screen strainers are placed in the gutter over the leaders. I recommend removing the screen strainers. If leaves build up in certain areas, a rigid mesh could be installed over the top of the gutter which allows leaves to blow off rather than accumulate in the gutter. Additionally, several loose shingles were found. Loose shingles will blow off in high windstorms. The overall condition of the shingle roofs on all the buildings, in my professional opinion, was poor to fair with only 1–3 years of remaining useful life. A hurricane could reduce that life considerably. Many fasteners were rusted and backing out. When the roofs are replaced, consider an architectural asphalt shingle. The architectural shingles look better than 3-tab shingles and can carry longer warranties. Since the shingle roofs are very visible, the aesthetic component should be considered. Consequently, I'm not aware of any work to extend the useful life other than re-nailing where exposed fasteners are loose or missing. No coating application will be found to be aesthetically pleasing. Similar to the flat roofs, some rotted sheathing should be expected. Rotted sheathing cannot adequately hold nails and shingles, even if new, can and will blow off in high windstorms. Therefore, anticipate approximately ten (10) percent of the shingled roof area sheathing will likely need replacing. Some sheathing was curling, creating openings behind the gutter which will allow water into the building envelope. Although no active leaks were reported, water is still likely entering into the soffits

P-2 Algae Growth on Shingles

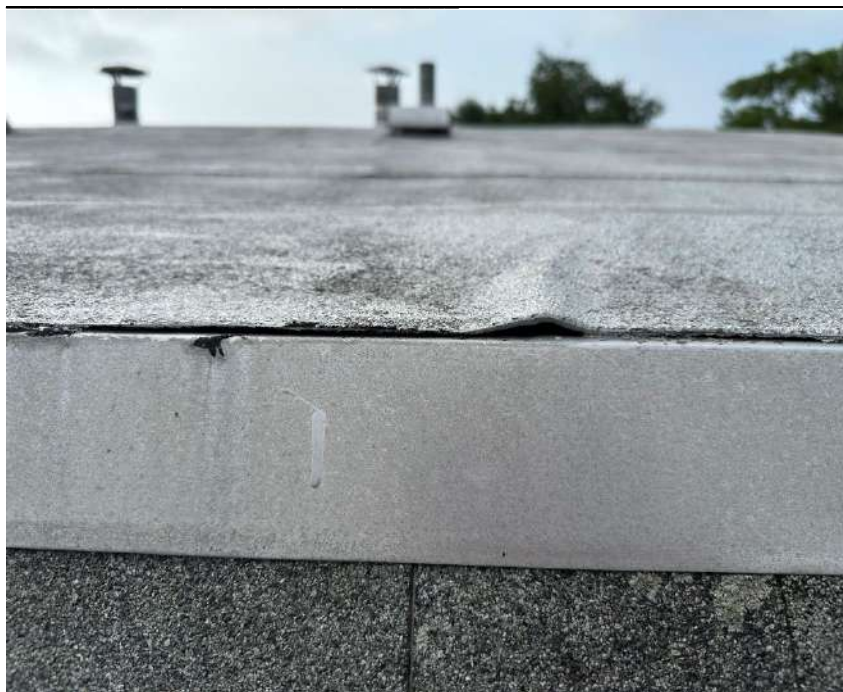
In addition to coating or application of a new recovery membrane, making some repairs to the defects observed to the bituminous membrane roof areas will also extend the remaining useful life of the roof. The observed defects to the bituminous membrane roofs include some small openings in the seams and where the membrane transitions to roof edge metal. Open seams can allow water to enter the system

P-4 Fish Mouth

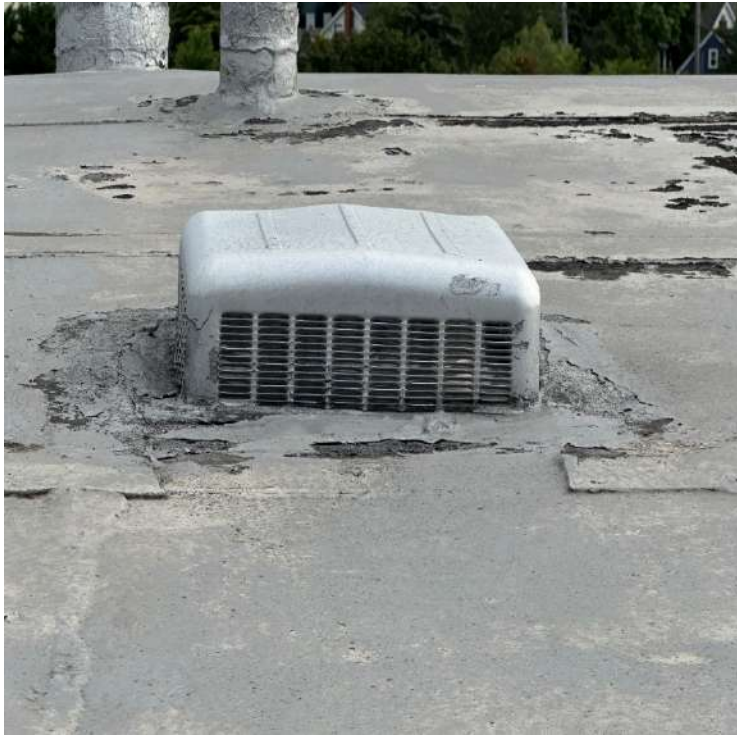
The flat roof areas on buildings 2,4,5 and 8 have smooth modified bituminous membrane roofs with a fibrated aluminum coating. The smooth bituminous membrane is the same as the granular surfaced bituminous membranes except they don't have the granules. The smooth modified bituminous membranes generally appear newer than the granular surfaced membrane. More specifically, the smooth modified bituminous membranes exhibited some alligatoring deterioration with cracking not as deep as that observed on the membranes with granules. I therefore estimate the remaining useful life of the smooth modified bituminous membrane roof areas on buildings 2,4,5 and 8 at eight (8) to ten (10) years.

P-10 Smooth Modified Bituminous Membrane With Fibrated Aluminum Coating

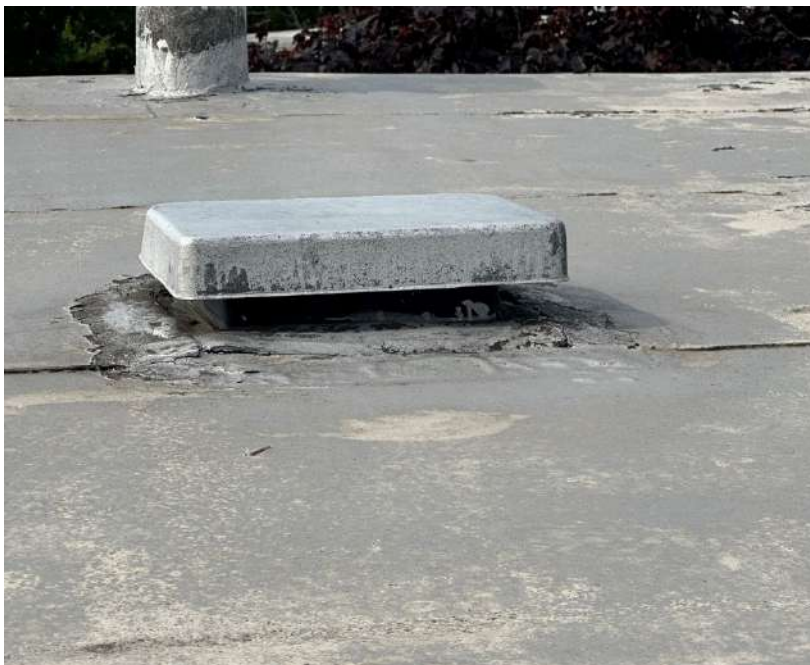
P-11 Exhaust Fan

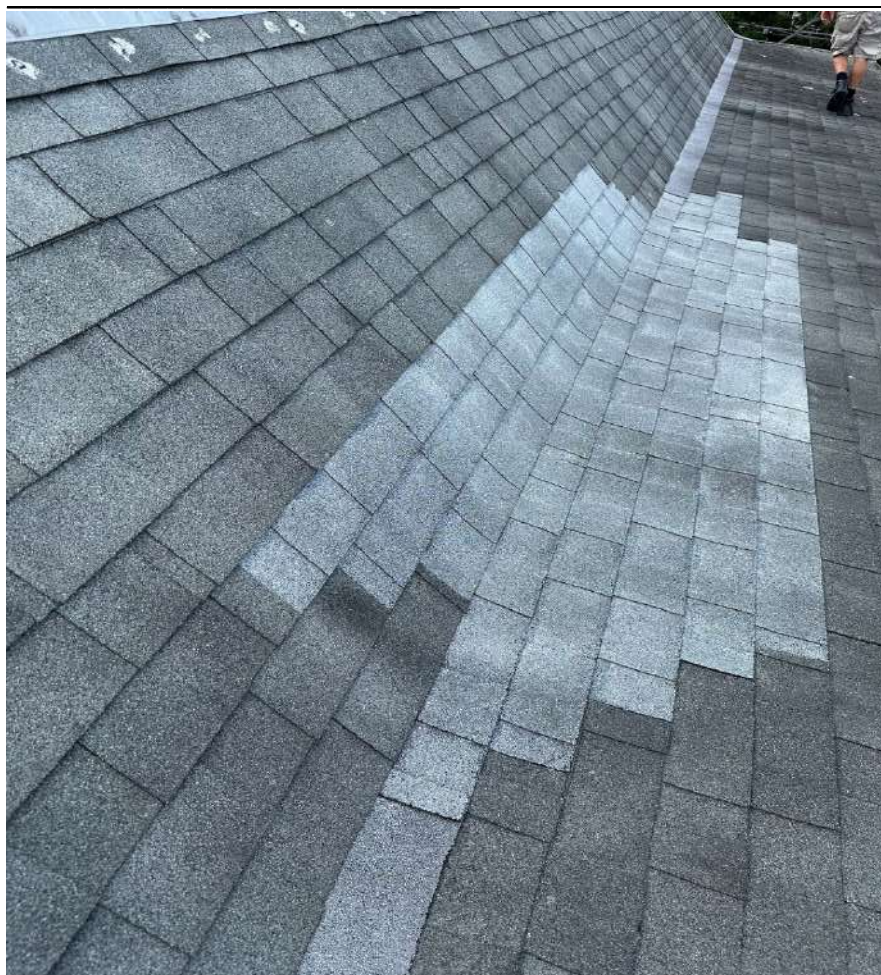
P-18 Prior Replaced Shingles

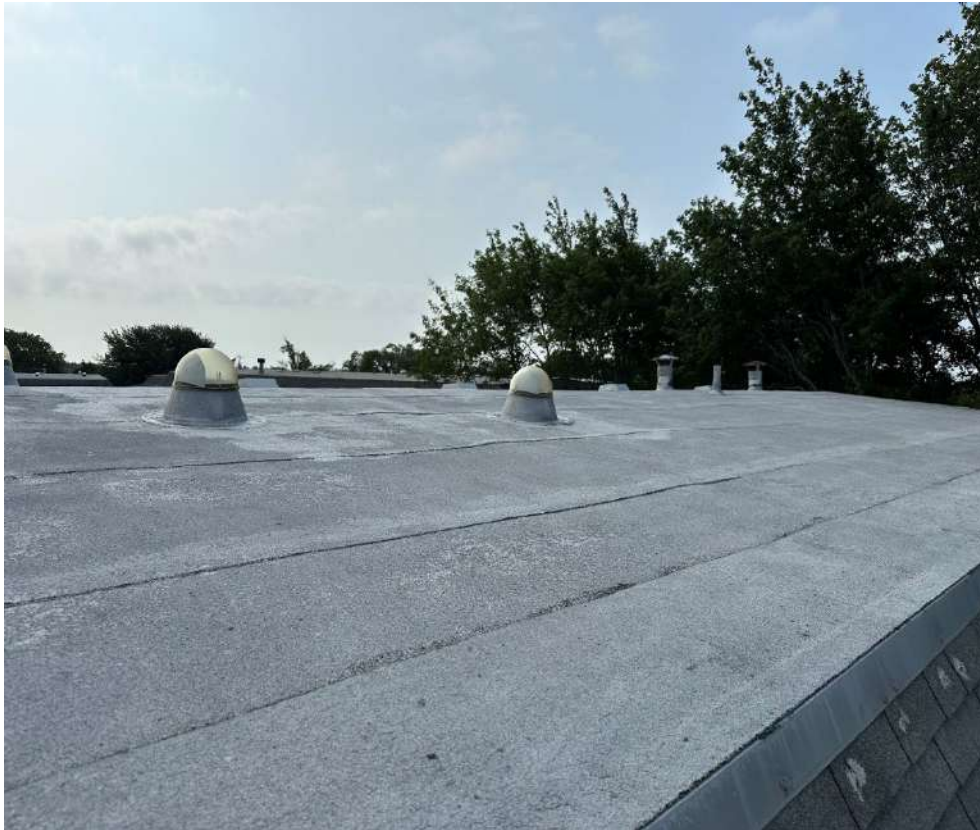
Buildings 1, 3 and 6 were found to have a granular surfaced modified bituminous cap sheet membrane with a fibrated aluminum coating. A modified bituminous membrane is an older style asphaltic roof membrane reinforced with fiberglass. The granules are factory installed on the top of the membrane are similar to those on the asphalt shingles and are there to protect the membrane from damaging ultraviolet (UV) rays from the sun. A fibrated aluminum coating is basically a reflective aluminum-colored paint meant to reflect the UV rays from the sun, which do over time cause the breakdown of the membrane. The addition of a fibrated aluminum coating over a granular surfaced bituminous membrane is redundant. Regardless, the granular surfaced bituminous membranes on Buildings 1, 3 and 6 exhibited some moderate alligatoring. Alligatoring is cracking of the membrane, and the name originates because the crack pattern resembles the pattern of an alligator's skin. Cracking of the membrane eventually will lead to its inability to resist water penetration. Therefore, I estimate the remaining useful life of the granular surfaced bituminous membrane roof areas at approximately 3–5 years and would characterize their condition as poor to fair.

P-19 Granular Surfaced Modified Bituminous Membrane  
with Fibrated Aluminum Coating

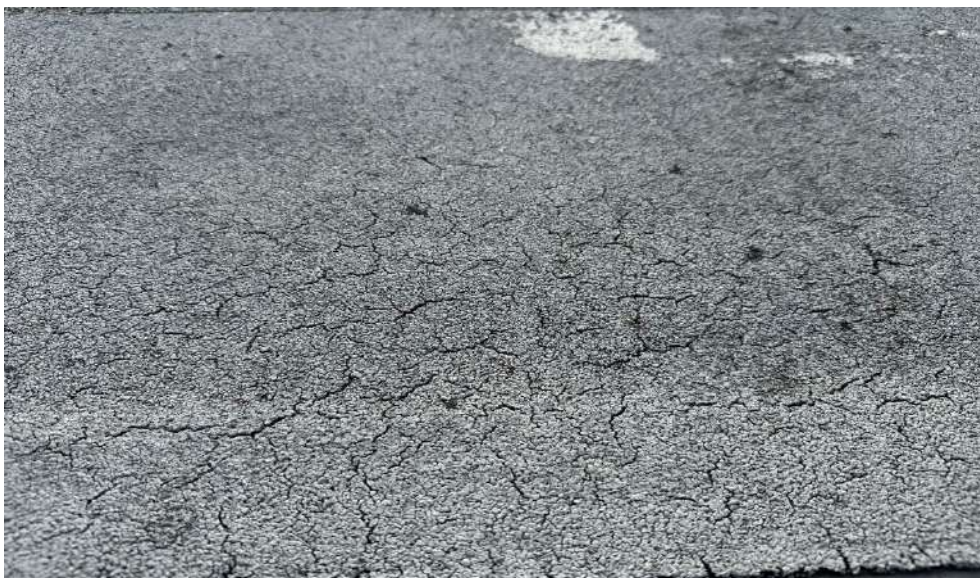
To try and extend the remaining useful life of alligatored modified bituminous roof membrane requires the application of a heavy-duty elastomeric or fiber-reinforced liquid coatings that can bridge interconnected micro-cracks and restore UV protection. The exact product(s) to use and varied warranties available would need to be explored further. GAF manufactures silicone roof coatings such as GAF Unisil II.

P-20 Alligatoring in Membrane

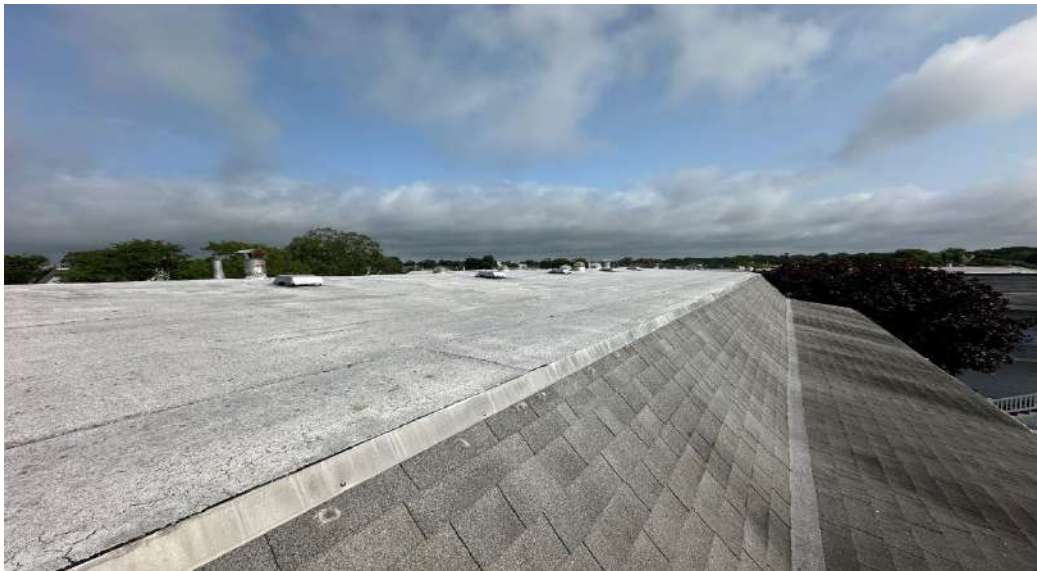
P-24 Overall of Roof

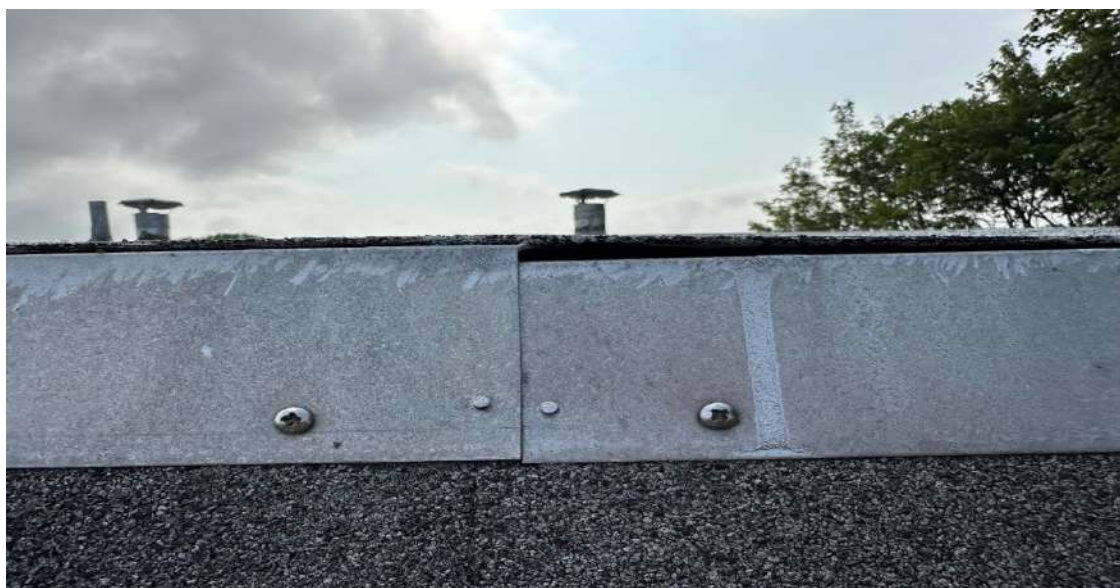
P-26 Gap at Fascia and Shingle Exposing Sheathing

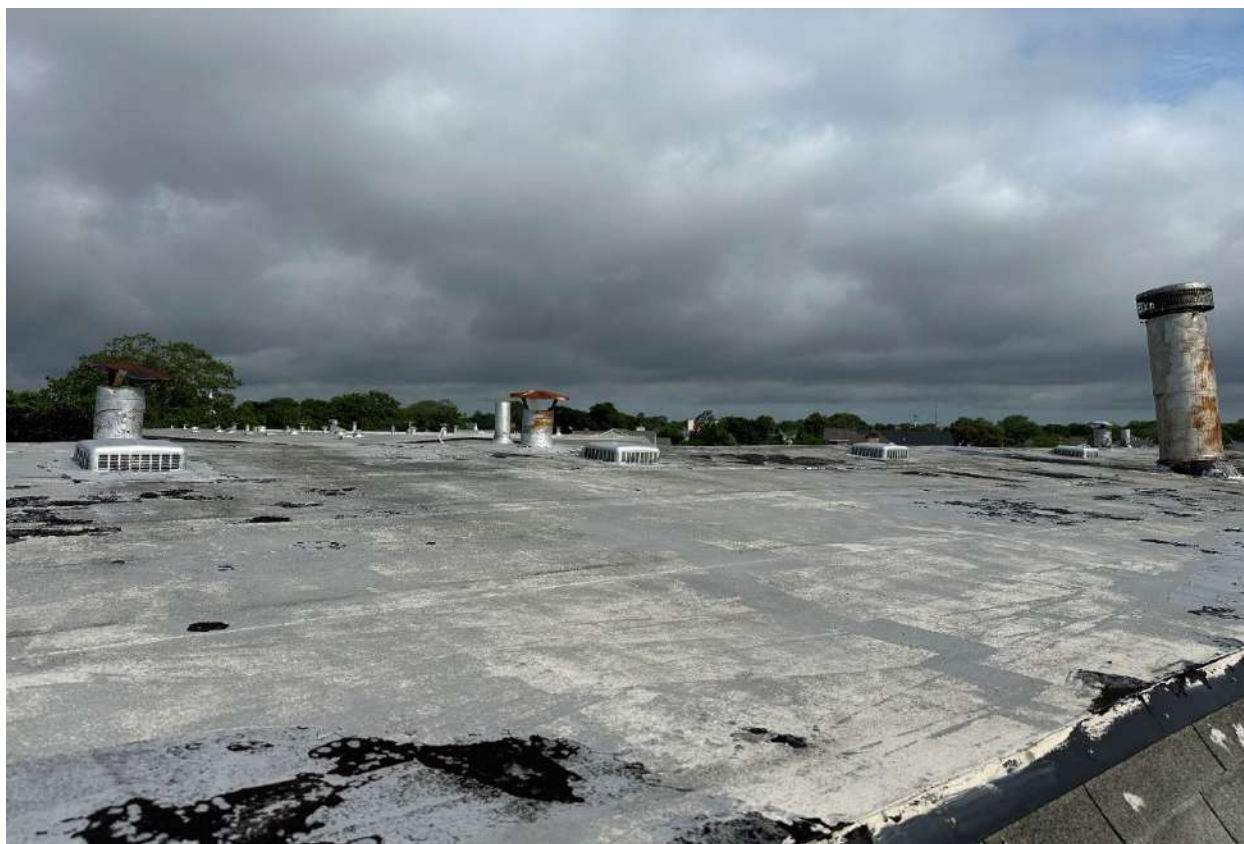
P-27 Smooth Bituminous Membrane With Fibrated Aluminum Coating

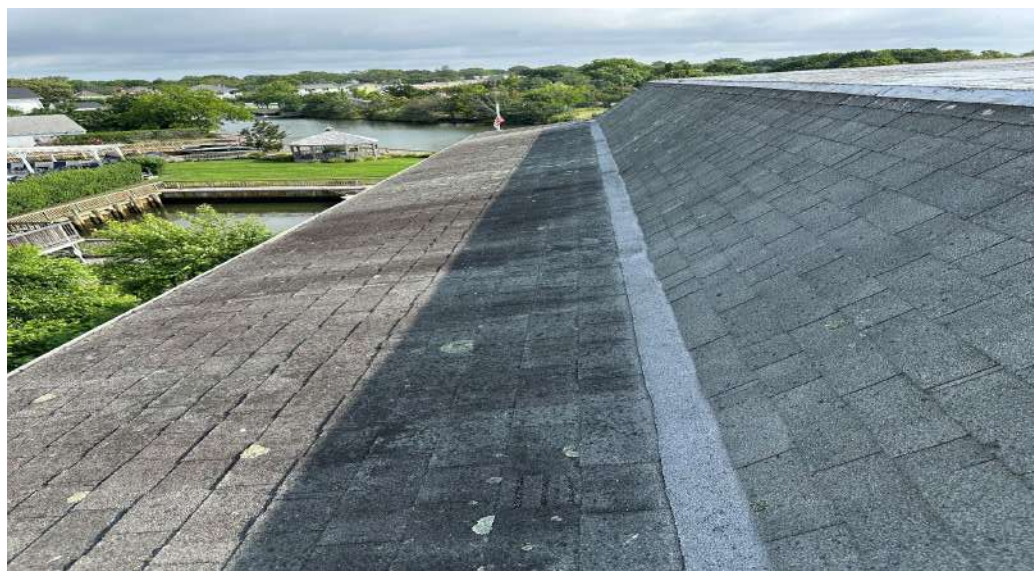
P-28 Asphalt Shingle

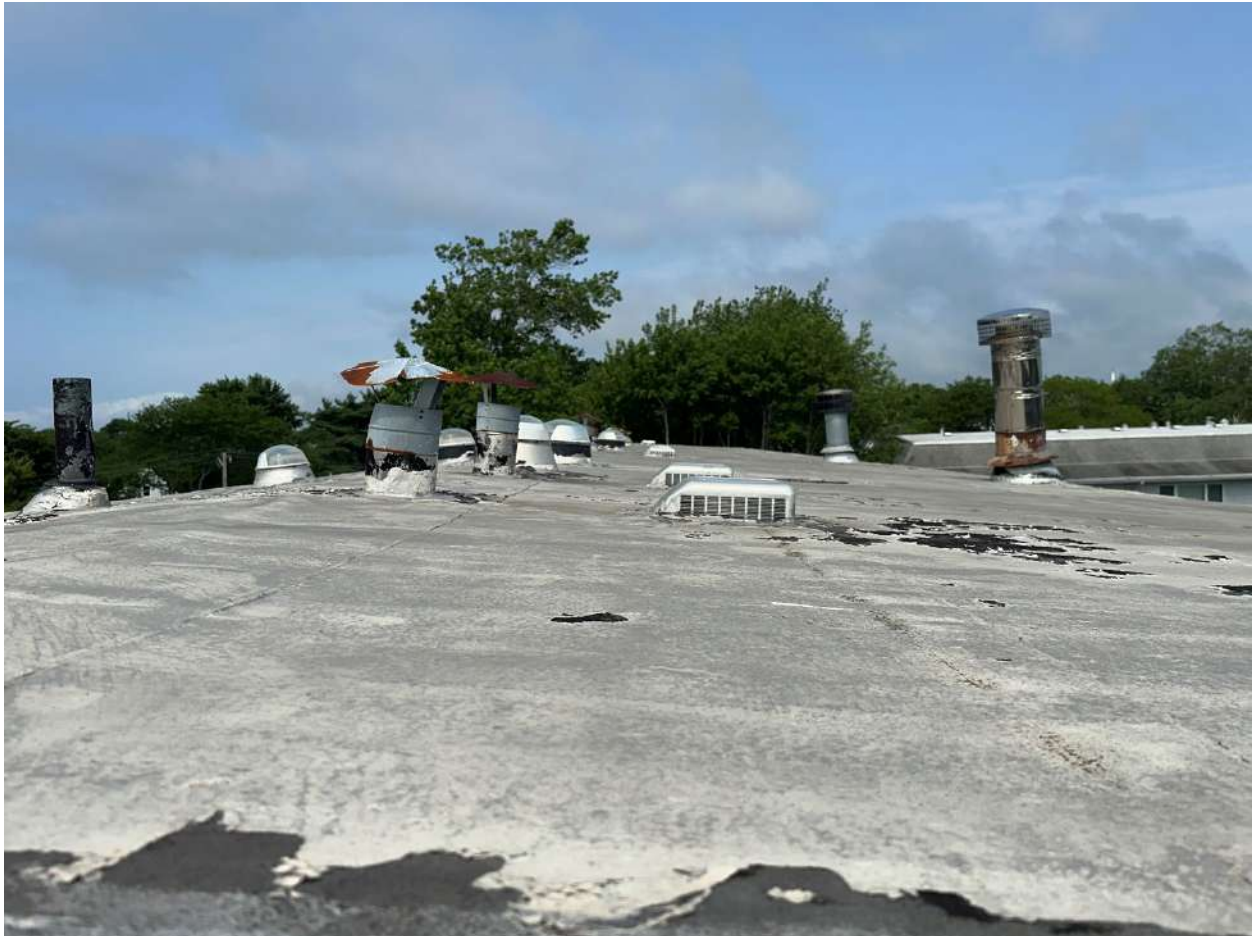
P-34 Smooth bituminous membrane with fibrated aluminum coating

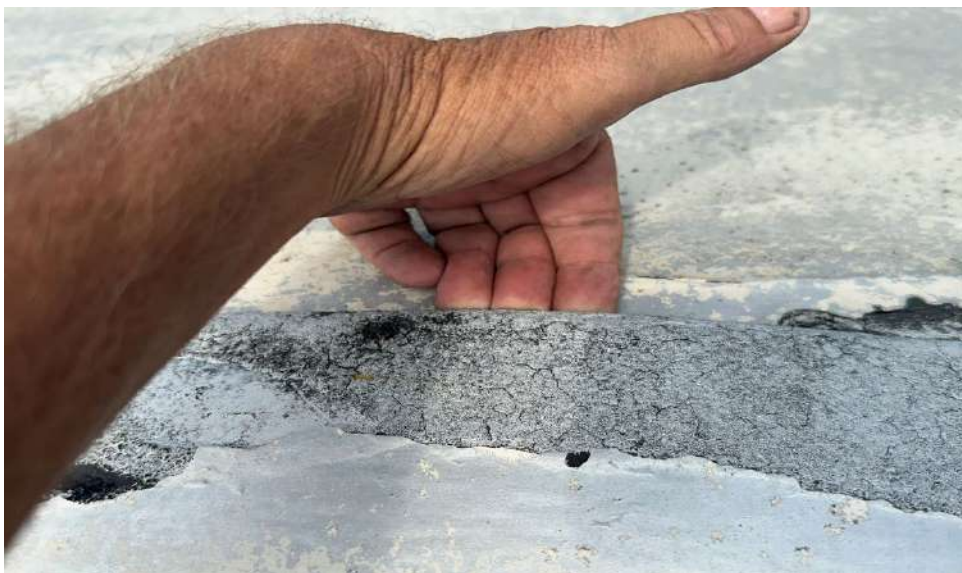
P-35 Opening in seam

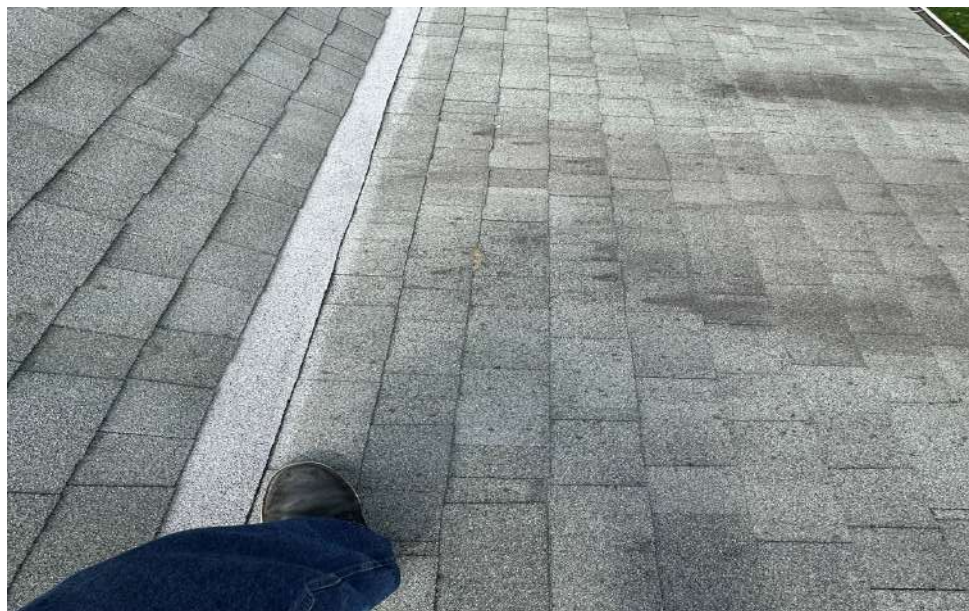
P-39 Asphalt shingle roof

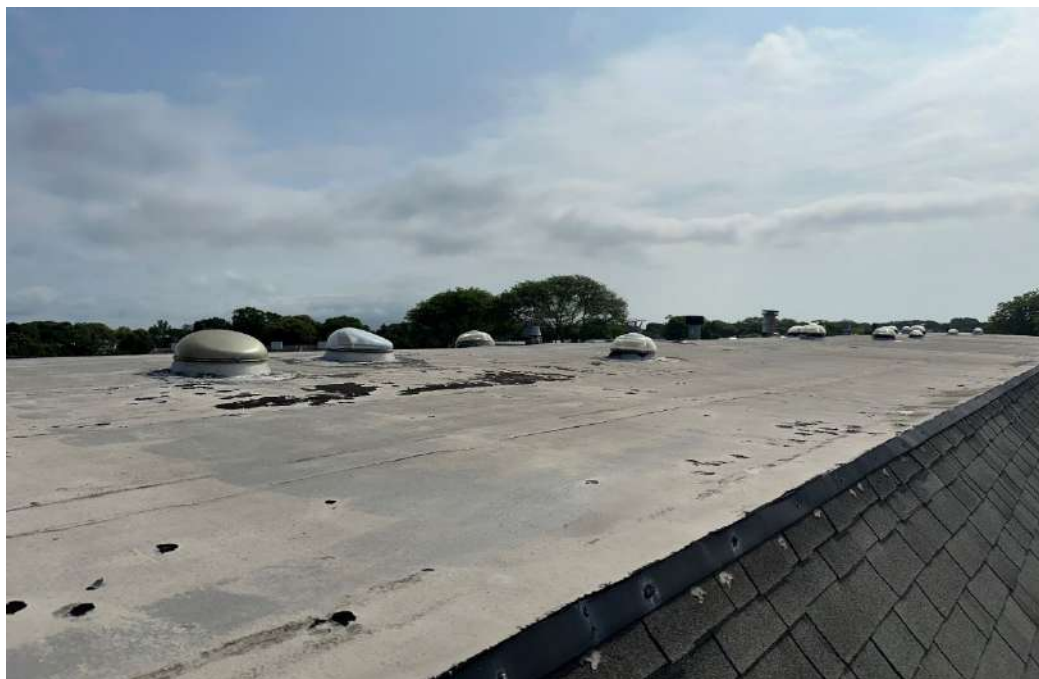
P-45 Asphalt Shingle

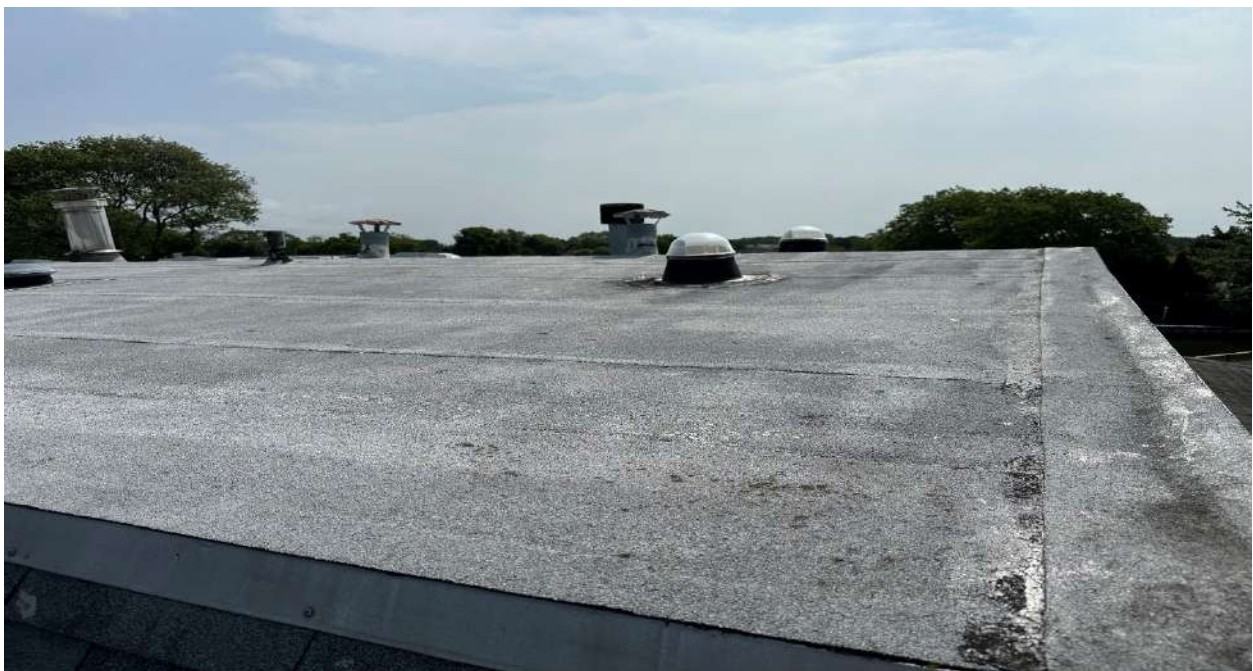
P-66 Granular Surfaced Modified Bituminous Membrane

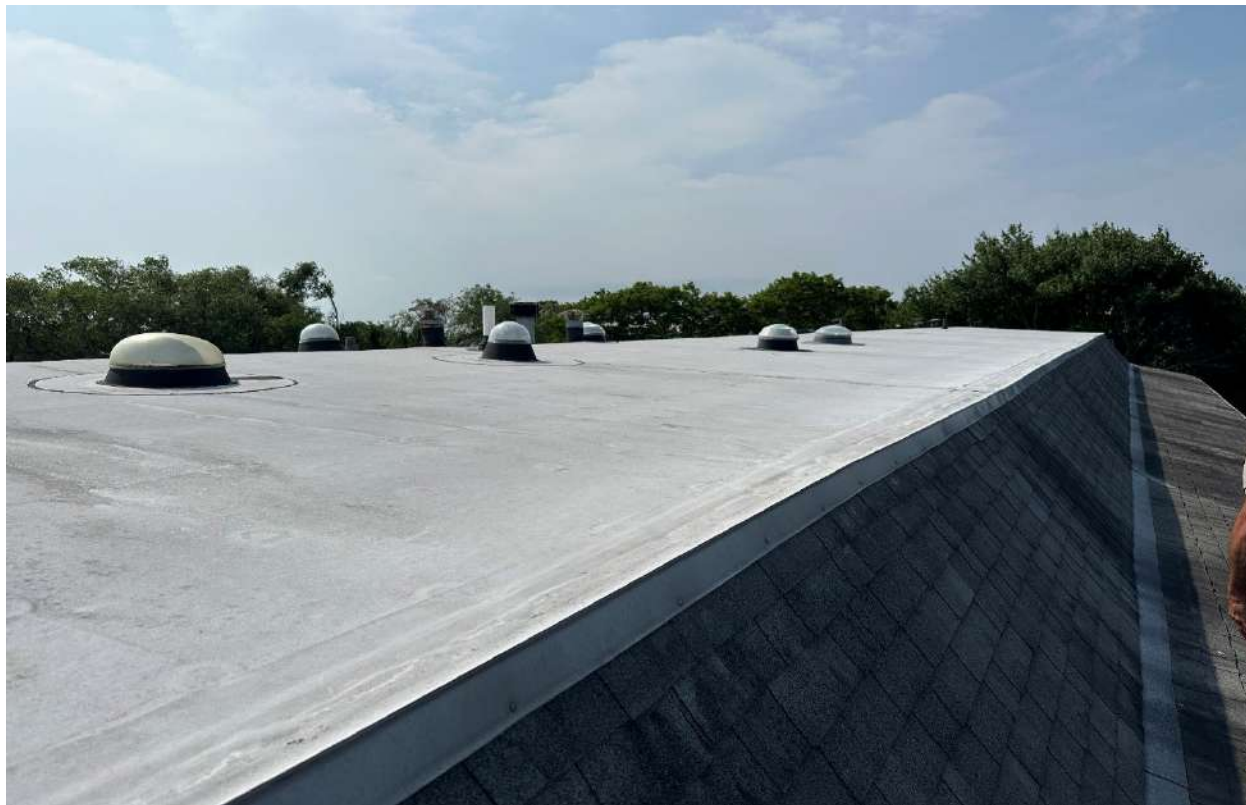
There was a white thermoplastic polyolefin (TPO) membrane on the flat roof area of building 7. The TPO membrane appeared to be the newest of the flat roofs and likely has approximately fifteen (15) years left of useful life. Some minor defects observed include some seams are beginning to open and missing base flashing at some of the solar tube skylights. Additionally, this roof area has some pressure relief vents that are meant to relieve water vapor and reduce the development of blisters. One of these relief vents was missing a cap (see photo 60). The missing cap maybe allowing water to enter the roofing system and should be repaired to maximize the remaining useful life.

P-53 White TPO Roof Membrane

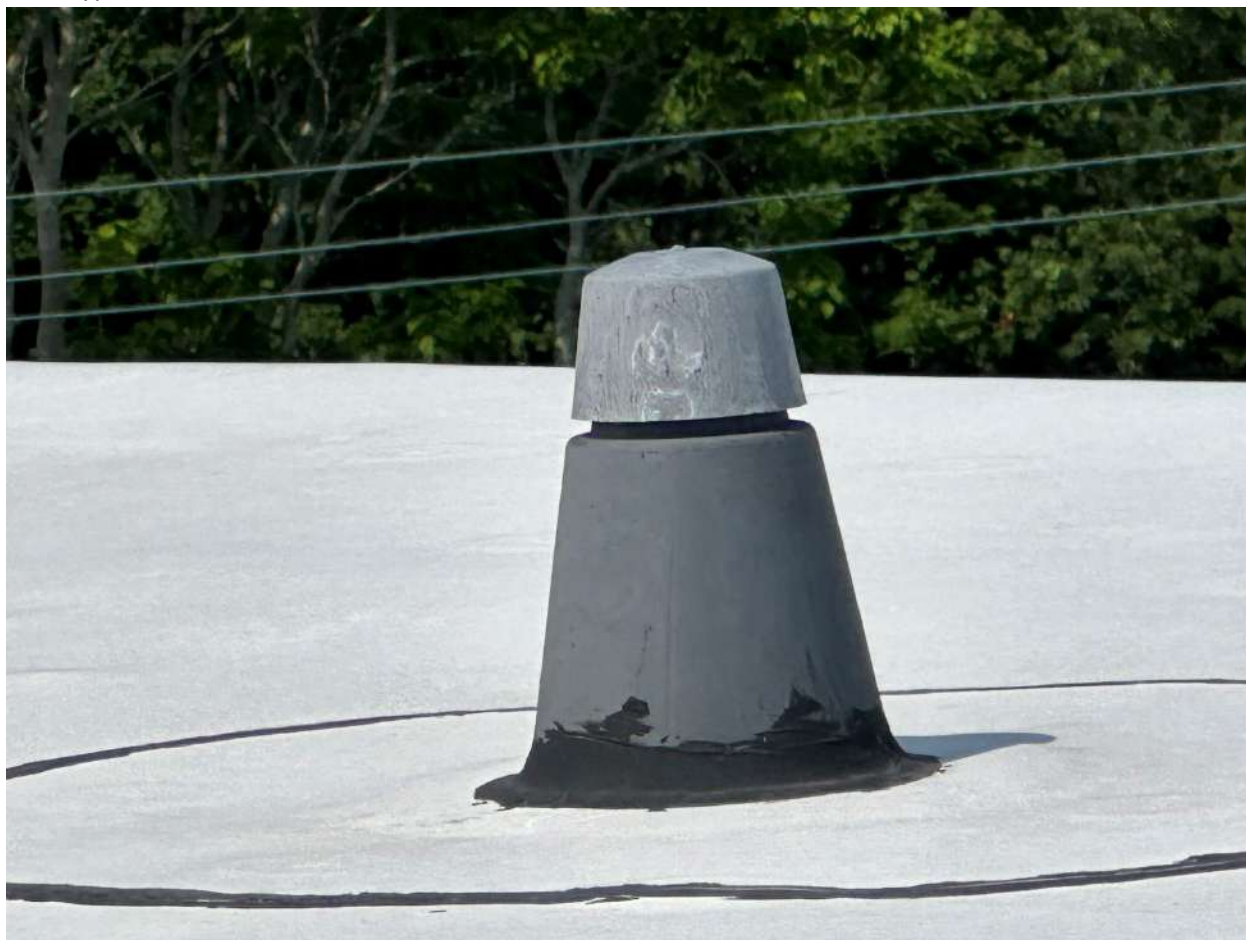
P-61 Typical Relief Vent

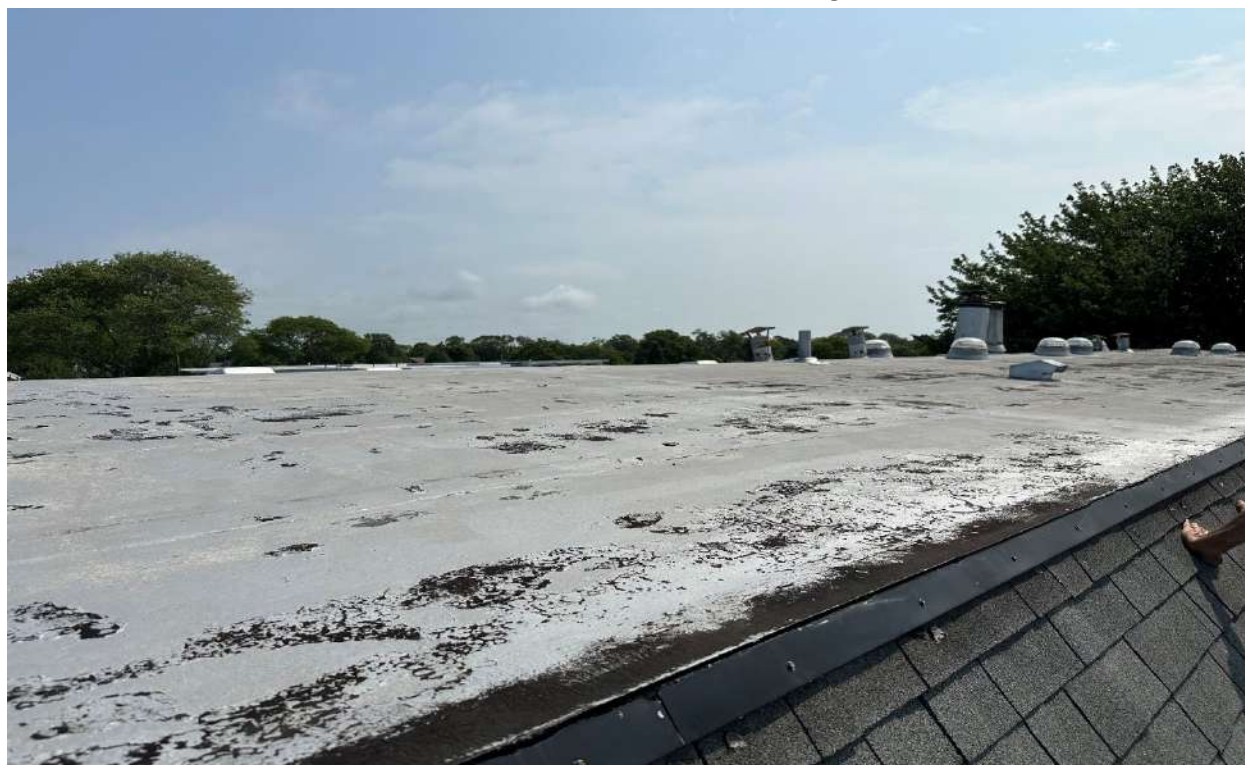
P-77 Smooth Bituminous Membrane With Fibrated Aluminum Coating
